## ALTICO SERVICE BULLETIN

**#ASB 060700**

**DATE:** JUNE 7, 2000

**SUBJECT:** STIFFENER IN TOP FLAP OF DOLPHIN MAIN CONTAINER

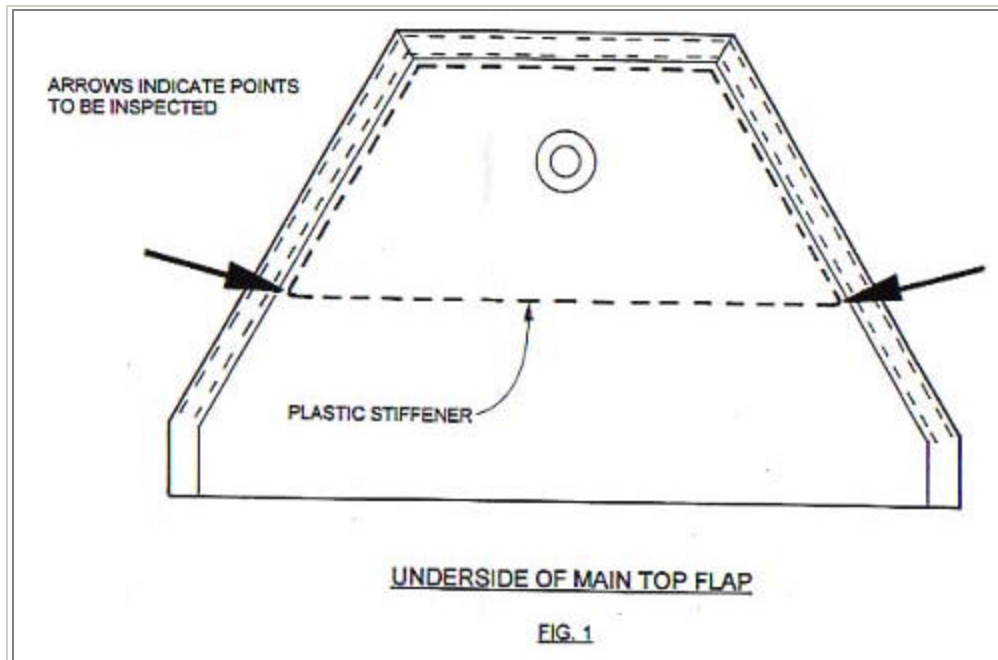
On the underside of the top flap of the main container, the corners of an unreinforced stiffener may wear through the fabric covering. Although this condition may easily escape notice during normal repacking, the exposed corner can catch a suspension line, producing a horseshoe malfunction. One such incident was reported December of 1999, with the reserve fortunately deploying through the malfunctioned main which remained caught by a suspension line after a cutaway had been attempted. In May 2000 a report was received that a rigger had noticed this condition during a routine inspection/repack, and the exposed corner was covered prior to the next jump.

- 1) Inspect underside of main top flap at points indicated in FIG. 1. If a corner of the plastic stiffener is exposed by wear, proceed to step 2.

Before Next Jump: Inspect any DOLPHIN system manufactured prior to February 2000. Determine if reinforcing tape is present. If not present, determine if the stiffener has worn through. If a corner of the stiffener is exposed, it is MANDATORY that this condition be corrected before the next jump. This repair/update may be performed by a suitably qualified rigger according to the instructions which follow, or by Altico.
