SICHERHEITSMITTEILUNG für Sprungfallschirme

Nummer: 05/2004

Betroffene Muster: ATOM MILLENIUM

Betrifft: Kontrolle der Klappe Nr.1 des Hauptschirmcontainers.

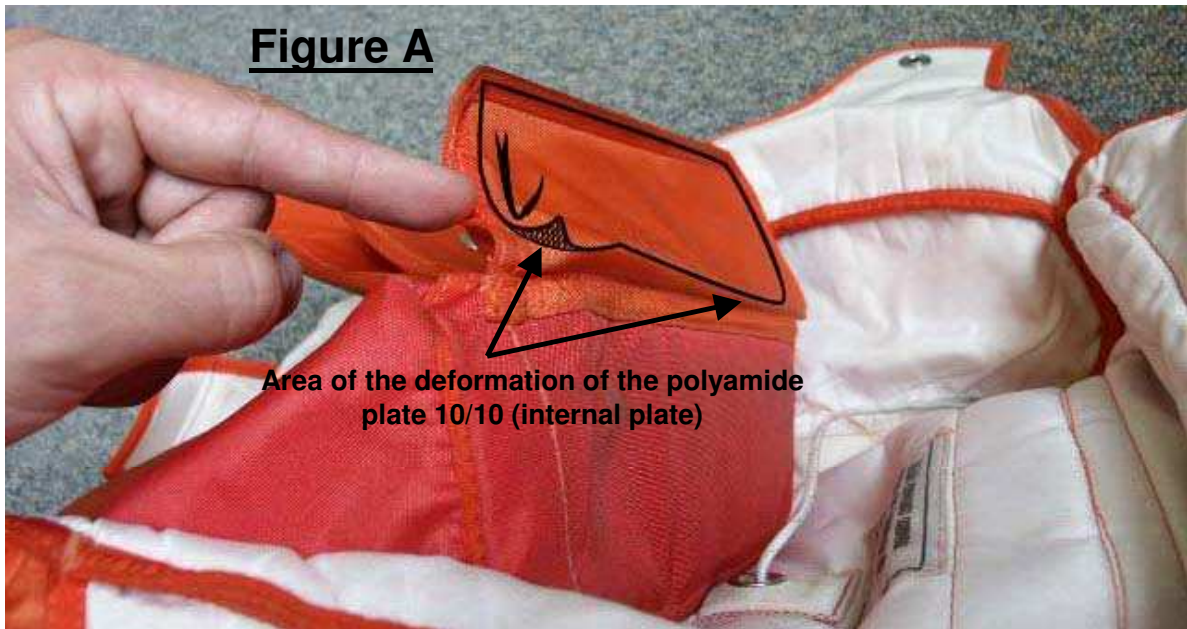
A deformation of the polyamide plate 10/10 (internal plate) of the deflector flap may occur near the sewing that binds the deflector flap to the container (see figure A).

Depending on the way the deflector flap is placed on the main deployment bag during the packing process, it may be deformed in time and its efficiency may be reduced.

Case N°1 : In the event of a deformation as shown on figure A : Before using the equipment again, get a qualified rigger to make a sewing on the deflector flap as shown on figure B.

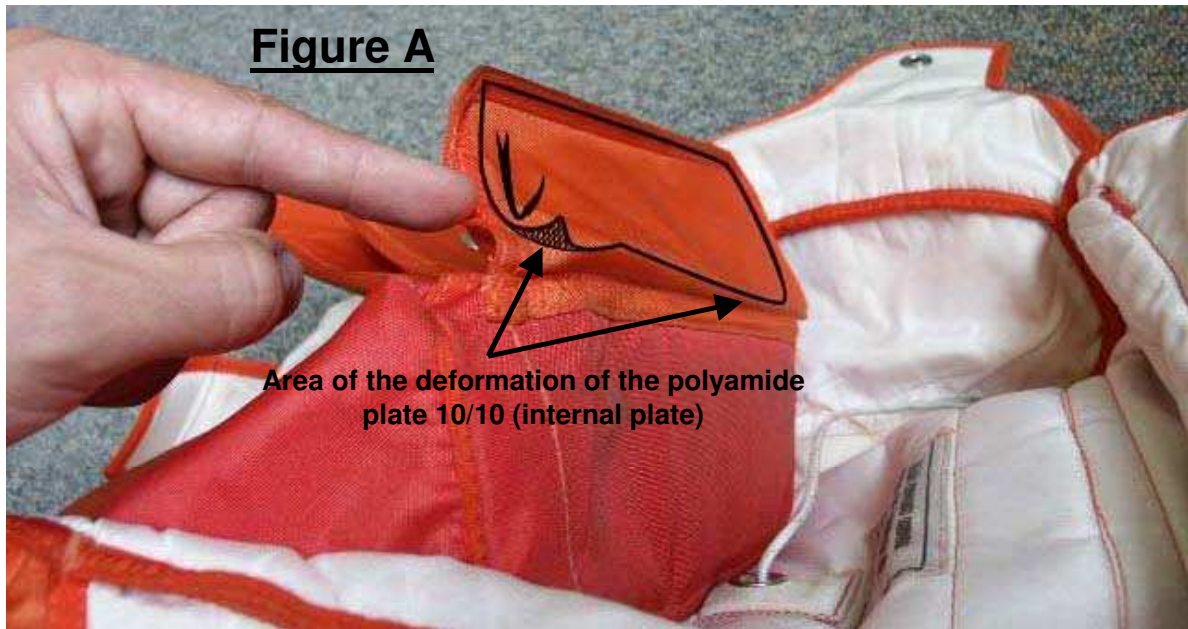
A deformation of the polyamide plate 10/10 (internal plate) of the deflector flap may occur near the sewing that binds the deflector flap to the container (see figure A).

Depending on the way the deflector flap is placed on the main deployment bag during the packing process, it may be deformed in time and its efficiency may be reduced.

Case N°1 : In the event of a deformation as shown on figure A : Before using the equipment again, get a qualified rigger to make a sewing on the deflector flap as shown on figure B.
