**SICHERHEITSMITTEILUNG**  
**für Sprungfallschirme**

Nummer: 01/2009

Bezug: Service Bulletin von Sun Path : # **SPSB005**  
**JH 101-3 (Hip Ring MLW) und JH 101-4 (4 Ring MLW) Beschädigung der Ringe**

**SERVICE BULLETIN SPSB005**  
**JH101-3 (HIP RING MLW) AND JH101-4 (4 RING MLW) RING DAMAGE**  
**INSPECTION**

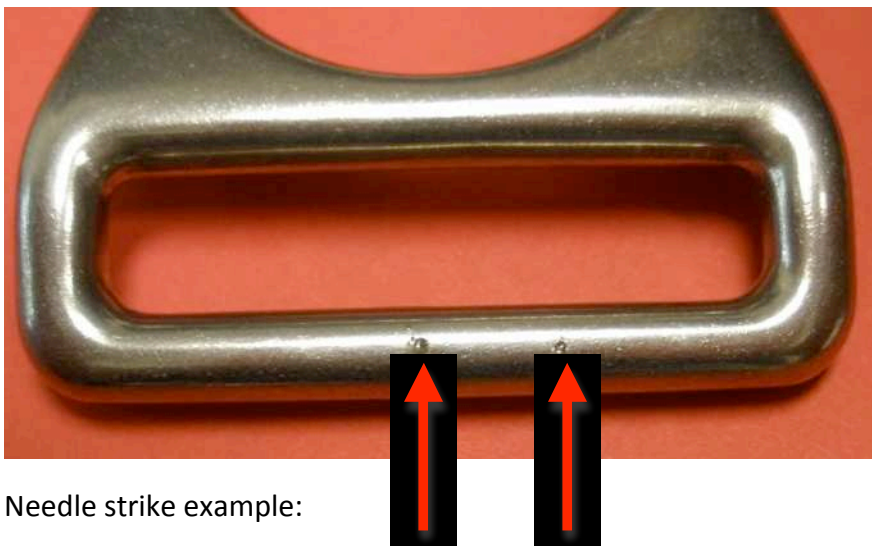
Needle strike example:

It has been brought to our attention that the hip ring on JH101-3 (Hip Ring Only) and JH101-4, (4-Ring) main lift webs, may have been struck by the needle used for installing the 5 cord harness stitching. This needle strike on the hip ring may cause damage to the Type 12 buffer, 5 cord stitching and possibly the Type 7 webbing. As a precaution, a mandatory inspection of the hip rings is required for all systems with a date of manufacture between **September 2008 and December 2008**.

The picture below is an example of a needle strike on an SR8 hip ring.

1. If damage is found or suspected, the harness/container will need to be sent to Sun Path Products, Inc. for repair. Please ship to the following address and include a completed Hip Ring Damage Repair Form found at the end of this document:

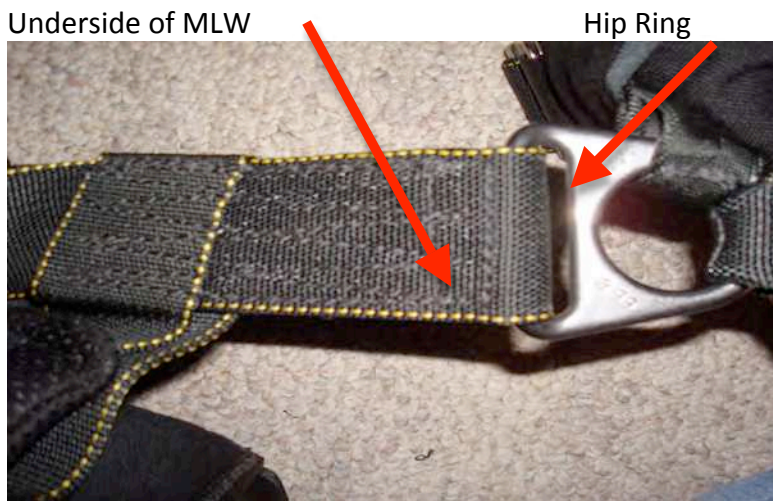
Turn Main lift web over, to expose the underside of the MAIN LIFT WEB (MLW).

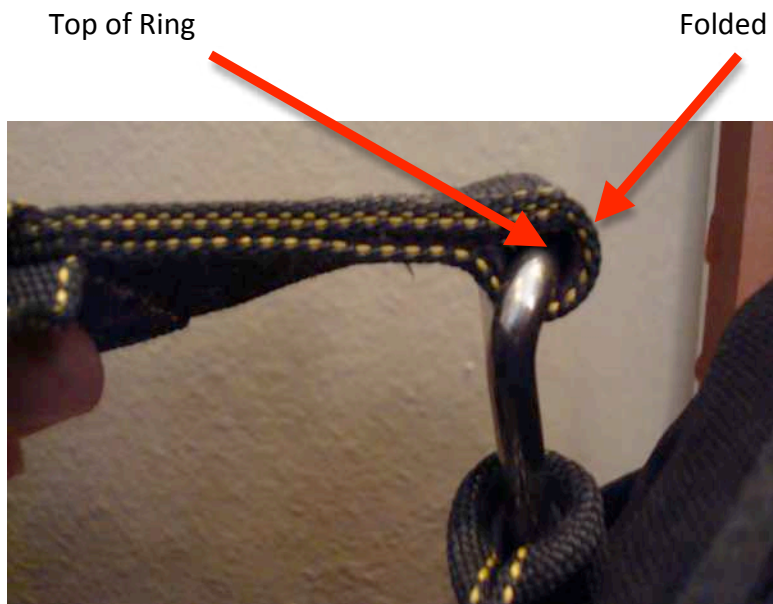
5. Rotate Hip ring and leg pad 90 degrees downward as to expose the top of the ring to the inside of the folded bottom end of the MLW webbing, as shown below.

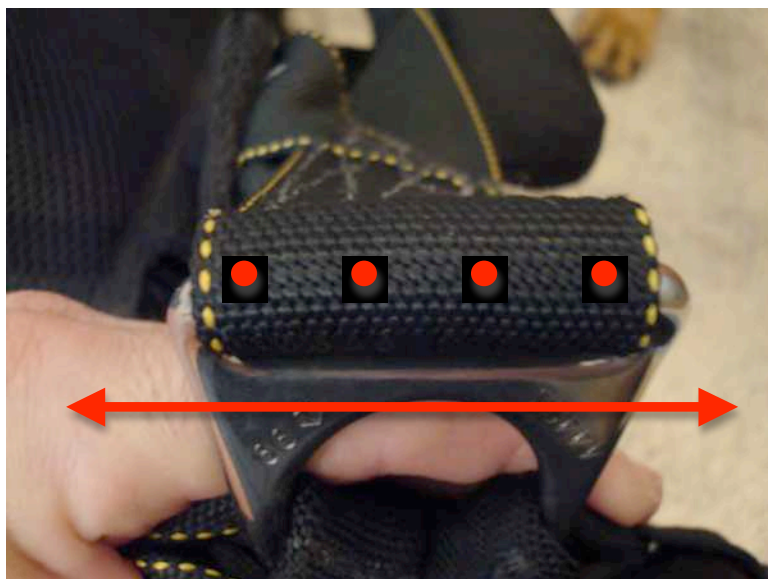
**BACK AND FORTH/ SIDE TO SIDE MOTION**

6. Move the hip ring back and forth (side to side) and rotate inside the webbing, while pressing the top of the ring through the webbing. If a needle strike is present, the rough spot on the top of the webbing bar of the ring will catch or snag on the TYPE 12 buffer on the inside of the TYPE 7 MLW. This will feel like a rough spot(s) on the top of the bar and cause a rough or snagging feel.

**FEEL HERE FOR DAMAGED RING INSIDE WEBBING. DAMAGE WILL MOST LIKELY BE ALIGNED WITH THE BOTTOM POINTS OF THE 4 POINT STITCH PATTERN.**

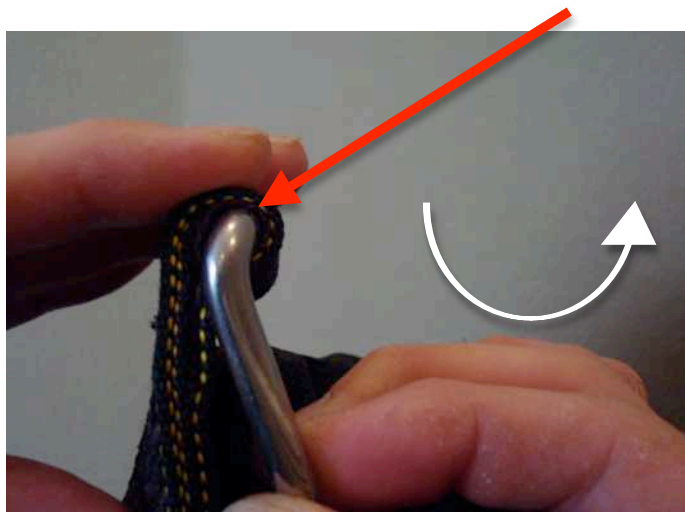
WHILE ROTATING, FEEL HERE FOR NEEDLE STRIKE.
