Technische Mitteilung
AAD

Nummer: 07/2010

Betrifft: den Tausch der Scheiben für den Reserveloop

Bulletin number: SB AMMO071210/1

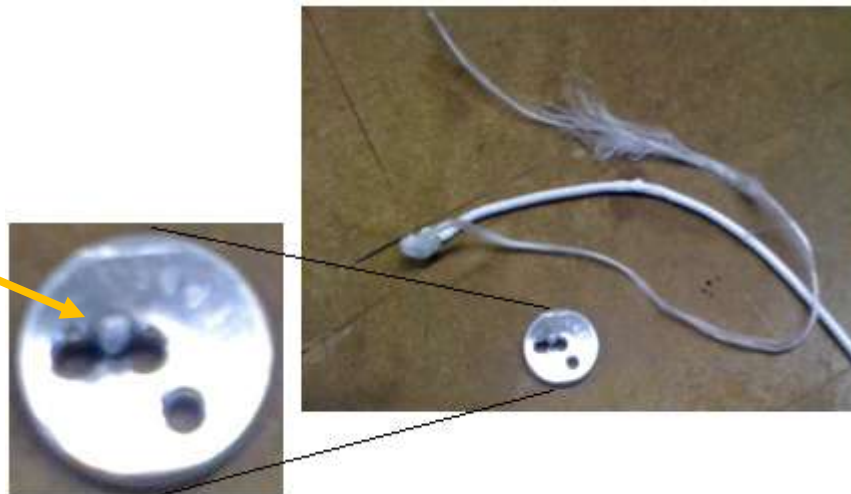
According to this update certain discs can break or rip from hole to hole. The problem is known by the disc supplier since 2009. According to the disc supplier at least 400 are still out in the field.

Washer ripped through

Due to metal fatigue, the disc can break at an unpredictable moment. A broken disc can break the reserve closing loop and cause an untimely opening of the reserve container at a critical time (e.g. floating and landing). Alternatively the damaged loop and/or washer may obstruct or delay the opening of the reserve container or hamper the reserve deployment.

All parachute systems equipped with an Argus AAD should have their disk checked and replaced after each repack. We highly recommend to replace all smiley washers by stronger steel washers using a figure 8 knot for the loop. Free steel washers will be supplied upon request to all Argus users with mentioning serial number and date of manufacture.
