SICHERHEITSMITTEILUNG

herausgegeben: 14.04.2011
Nummer: 08/2011

PRODUCT SERVICE BULLETIN

Bulletin number: SB AMMO050910/4 -This Service Bulletin replaces SB AMMO050910/3

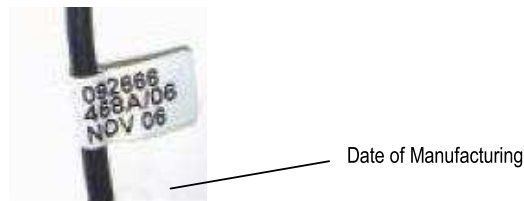
The cutter's manufacturing date can be identified by the cable tag:

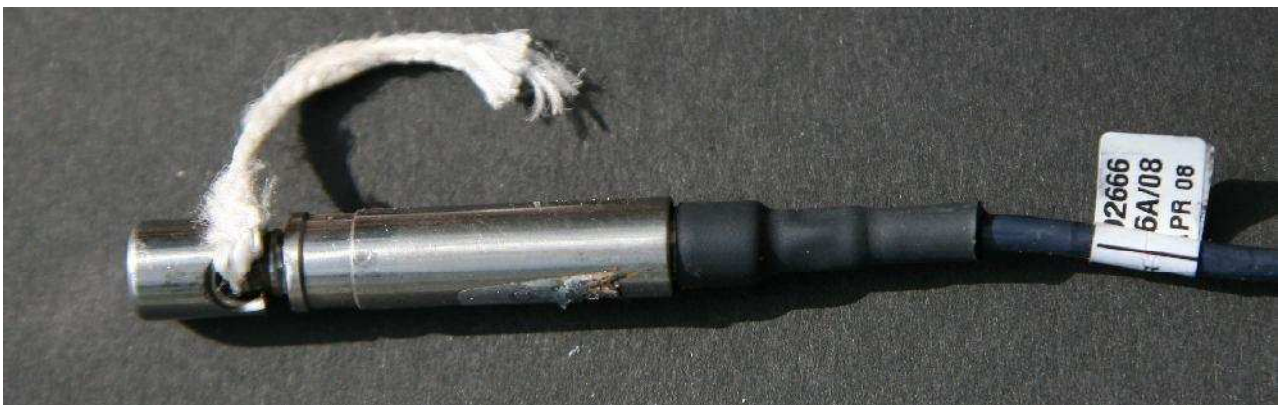
Picture 1: Disc cut with disc tools

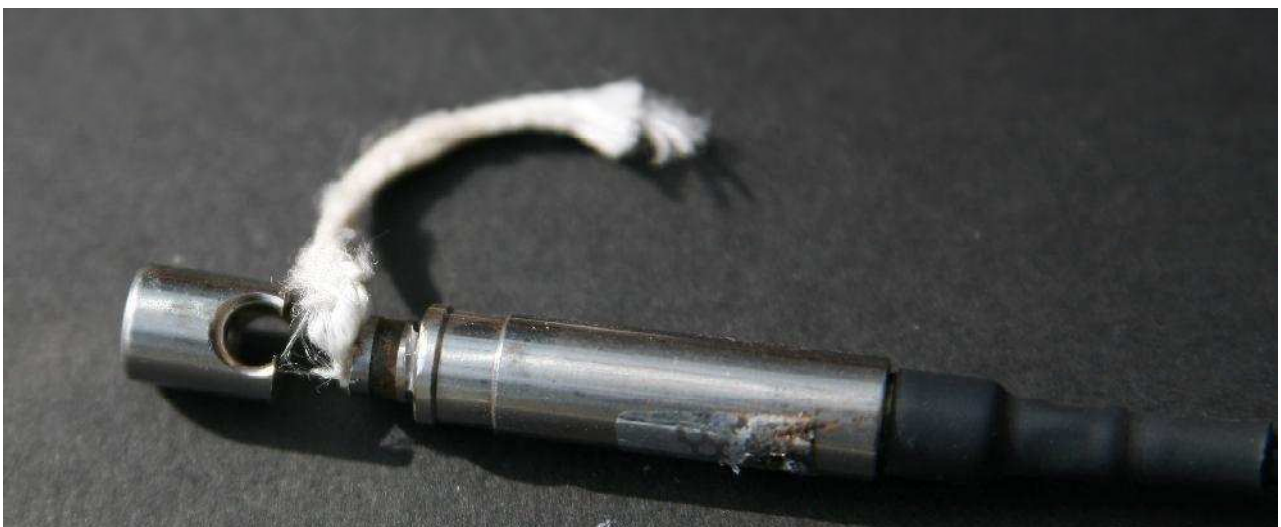
Picture 2: top separated from the body.

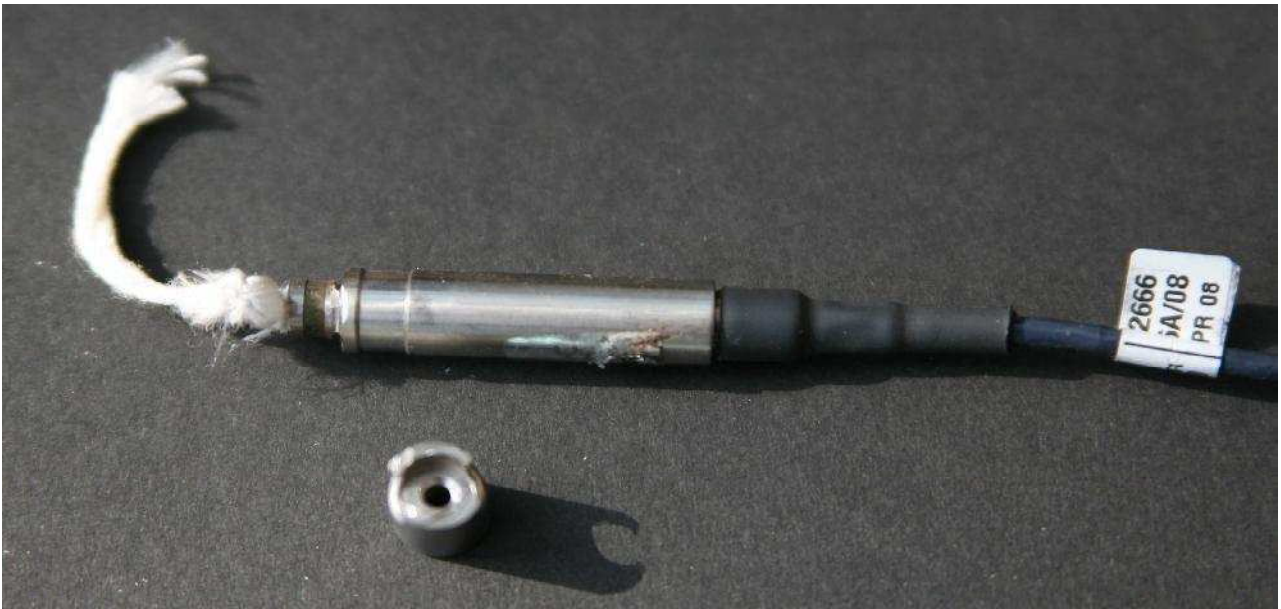
Picture 3: loop came off - together with the blade.

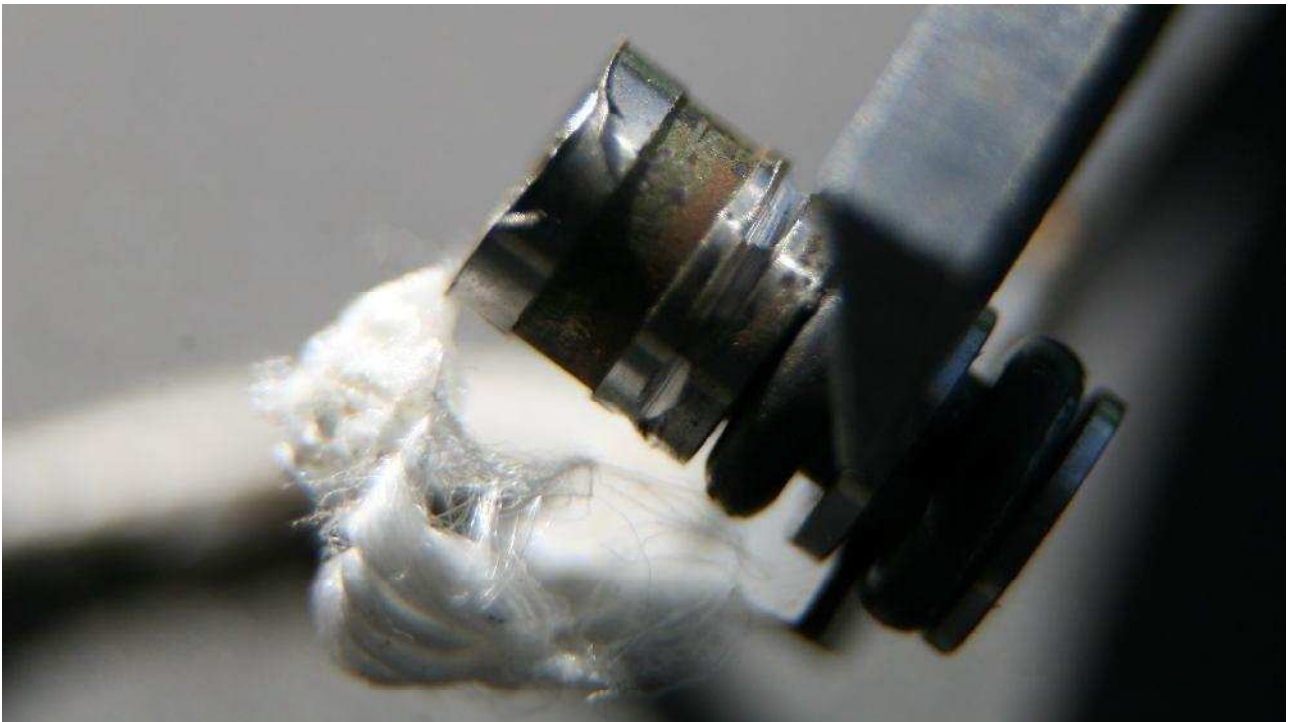
Picture 4: The edge of the bullet cutter was damaged on one side and showed two burrs.

The combination of the damaged cutter edge and the foreign object may have obstructed the complete cutting of the loop, since blade and anvil could not connect properly and the thermal cutting energy probably was partially lost since the loop showed no melting marks.

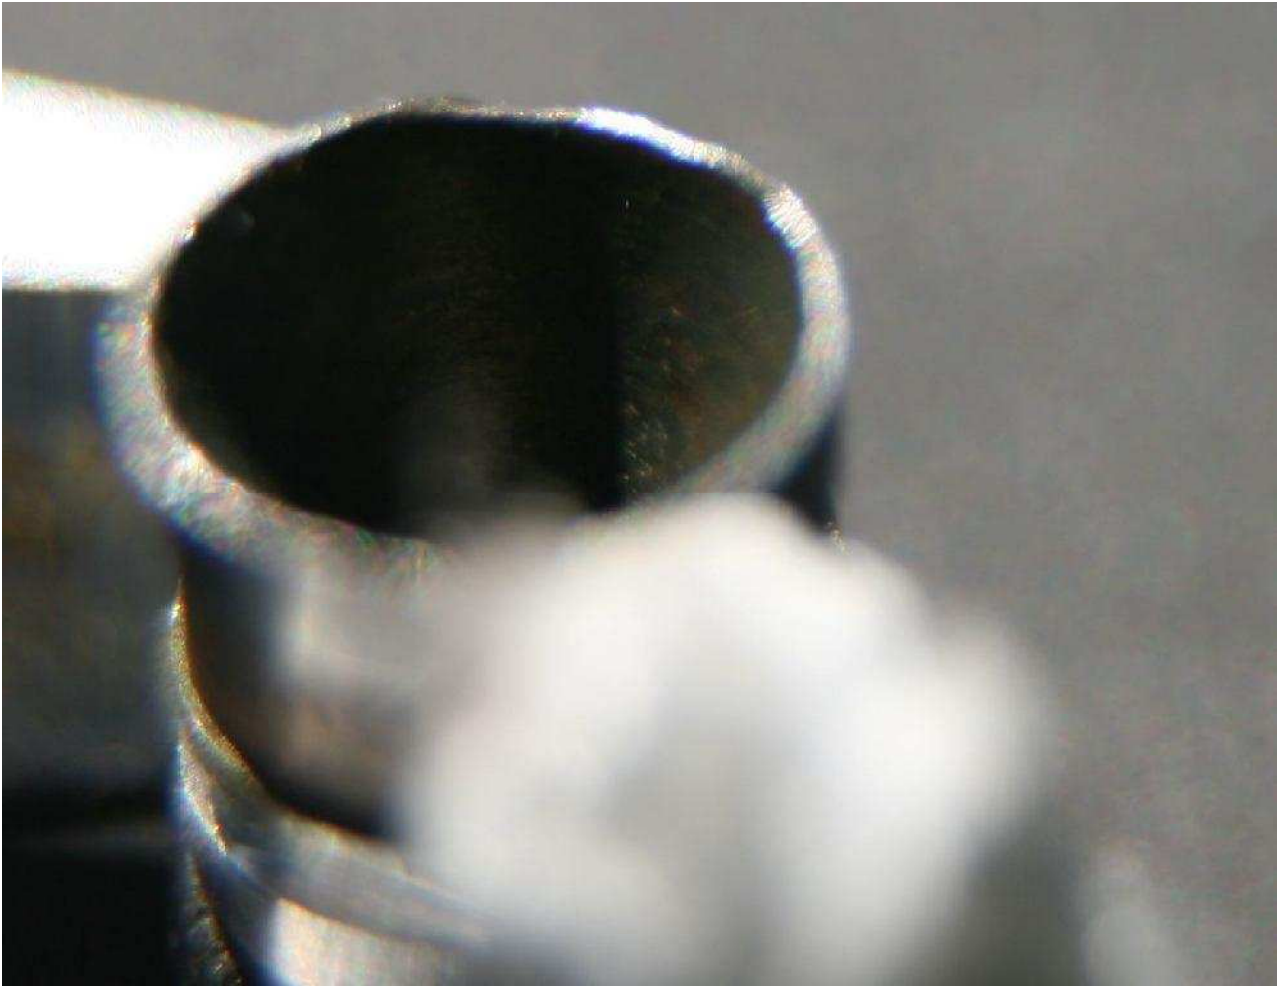
Picture 5: The cutting edge of the blade is damaged

The cutter was damaged in use. It is impossible to reinsert the damaged blade back in the cutter, so this could not have occurred in the factory.

Without the damage, there is no reason why the cutter should not have performed as designed. The loop material could not have caused any damage to the hardened stainless steel blade.

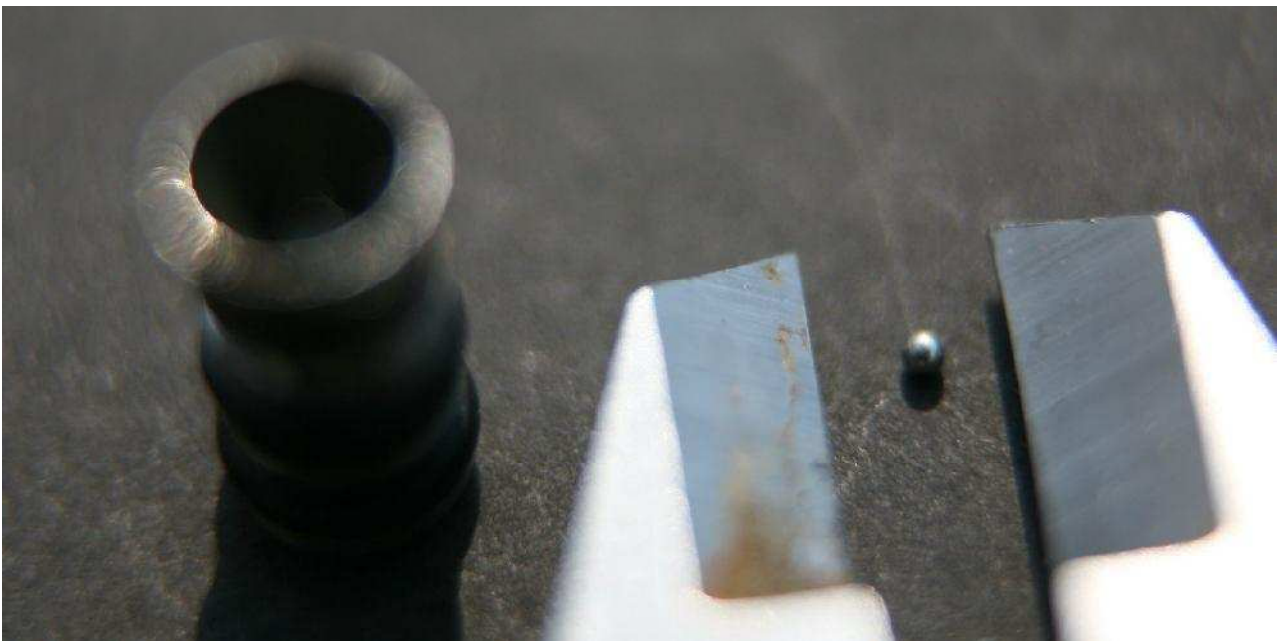
Upon removal of the pinched loop from the bullet cutter, a small metal foreign object fell out of the cup of the cutter. . Since the metal object was found between the loop and the blade, it is likely that it entered the cutter before the loop was inserted or later through the same hole. This looks like a small steel ball, as used in 'shot bags'

Picture 6: steel ball

Cutters have to be inspected at each repack for foreign objects that could interfere with the correct functioning of the cutter.

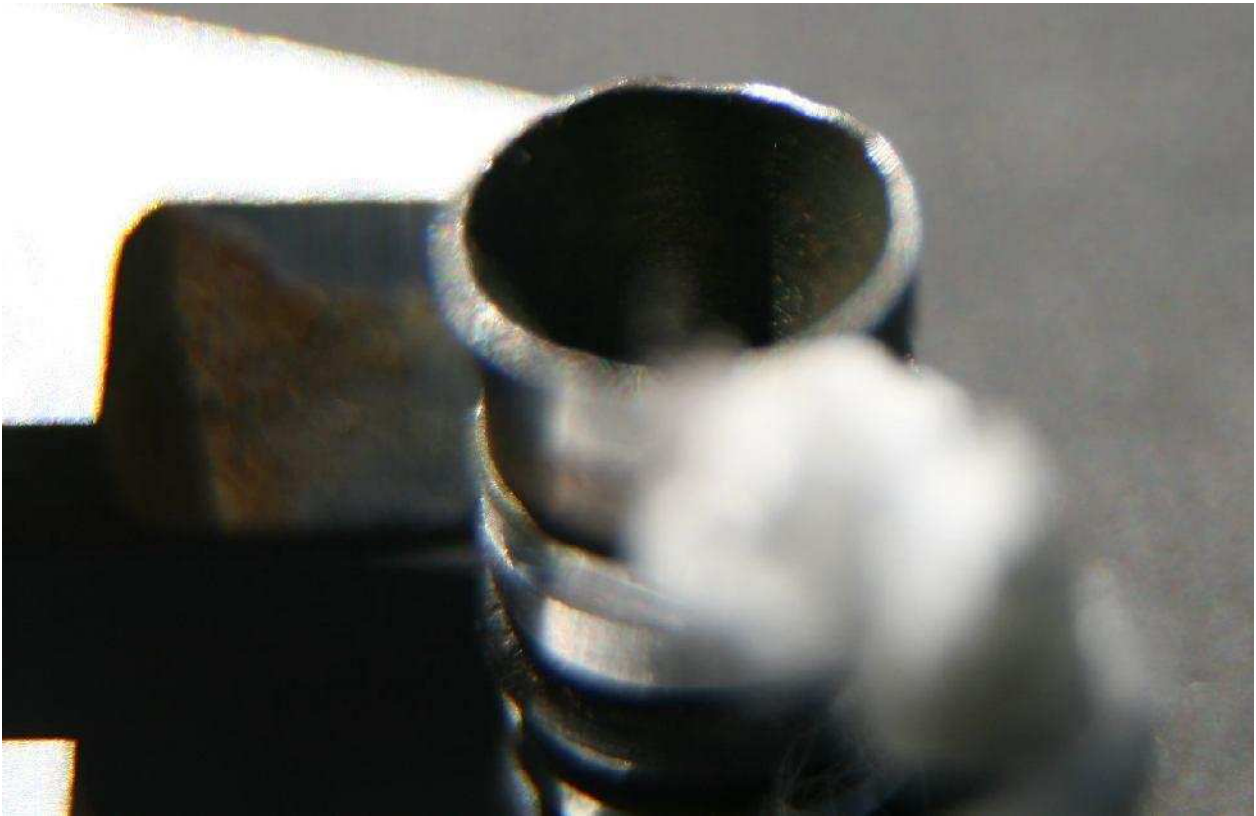
The cutter blade also showed a deformation at the place of the loop.

Picture 7: Damage caused by ball?

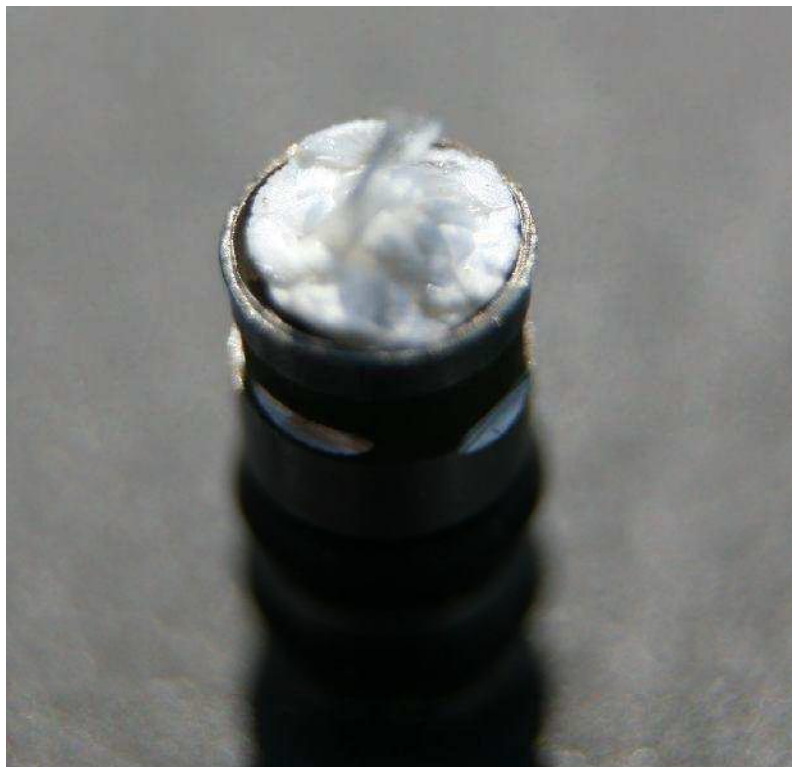
Picture 8: Comparative cutter open (DOM Aug 2007)

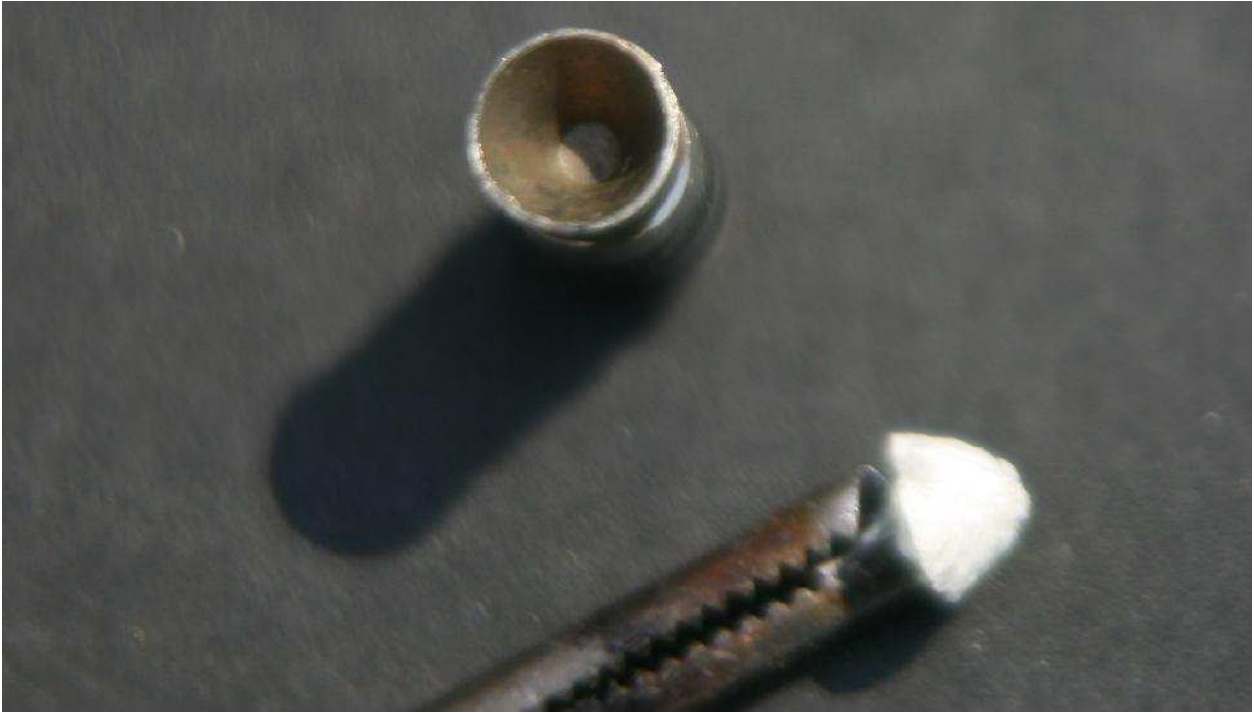
In order to compare, two more cutters were opened according to the same procedure. A molten cone of loop material was found in each cup of the bullet cutter.

Picture 9: Comparative cutter – Nice molten cone of Spectra fiber (Cutter DOM Aug 2007)

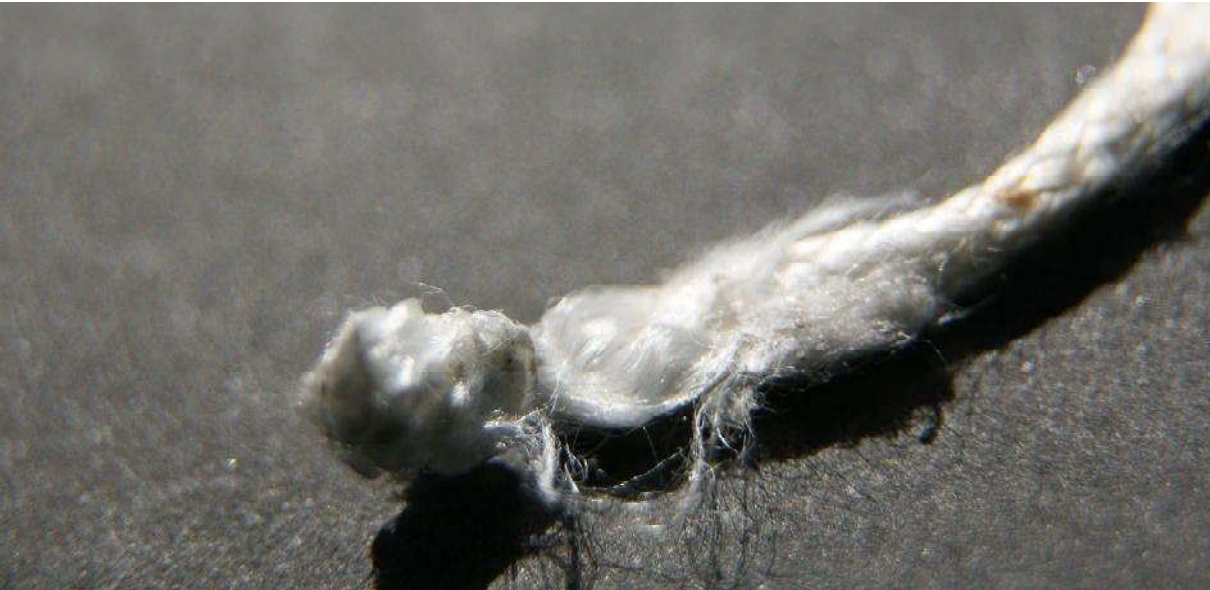
Picture 10: The trapped/pinched loop of the 'San Marcos' cutter

The blade could not perform its full stroke and thus not cut the loop completely.
