**SICHERHEITSMITTEILUNG**  
für Gurtzeuge

Nummer: 09/2011

Bezug: **SERVICE BULLETIN SB 20110523 vom 23.05.2011**  
**UPT für Vector-Gurtzeuge**

SERVICE BULLETIN #20110523

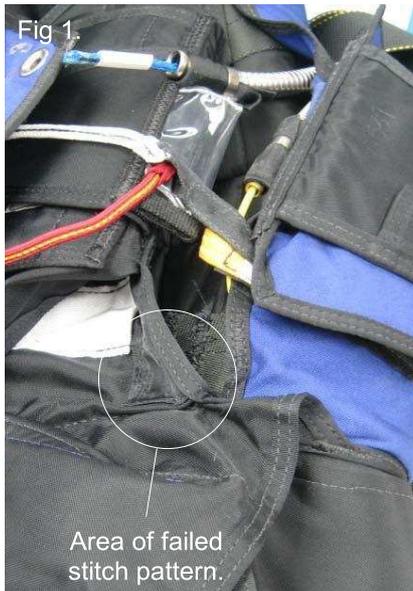
BACKGROUND: It was reported that a student jumper after pulling at a planned altitude of 5000', experienced a very hard opening and broke the upper double zigzag stitching that holds the diagonals in place and tore most of the ring cover off (See Fig1). This allowed the large ring riser attachment to be pulled far away from its normal position, deforming the over the shoulder section of padding and in turn pulled the RSL lanyard releasing the reserve pilot chute.

NOTE: It is unlikely this stitch pattern failed completely on this one jump, but was damaged on other prior jumps and completely failed on this one very hard opening. Further inspection of other Vector SE containers at the same DZ revealed other diagonals with various stages of stitch failure in need of repair.

Affected rig information- V392-2SE, Serial # 41750, DOM 25 Apr. 2005, estimated to have 500 to 800 jumps.

If the diagonals are in need of repair, riggers in the field are now authorized and requested to make this zigzag repair using "E" shape stitch pattern. This "E" shape zigzag stitch pattern is the same pattern that has been in use on the Sigma Tandem system for some time.

**PROCEDURE:** Slowly and carefully work your way back in between the reserve container and back pad as shown in figure 8. Ensure that nothing but what is intended to be sewn is under the presser foot. Each pass of zigzag stitching is done twice sewing over the tails of each first pass using size E, #69, T70 Nylon thread.

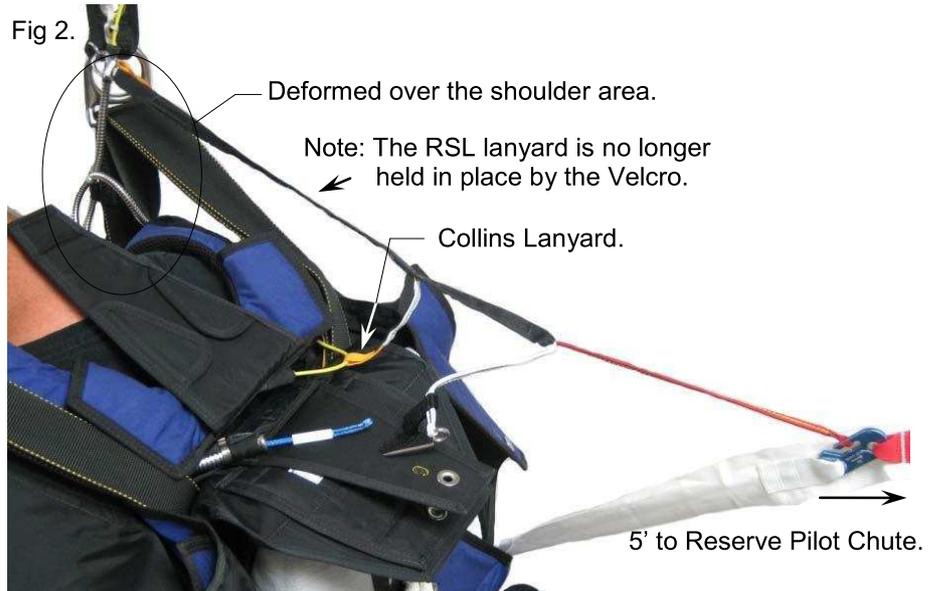
At an altitude of around 4500' the attachment point of the SkyHook and RSL lanyard produced a trailing reserve pilot chute (preventing a two out scenario) as witnessed from the ground (See Fig2). At an altitude reported to be between 225' and 250' the student jumper initiated a final approach turn, but due to the deformation of the right shoulder section of the harness, the Collins lanyard released the left riser from this turn input (See Fig2). The student then reacted by immediately pulling the cutaway handle releasing the right riser initiating a SkyHook direct bag deployment. After a very short reserve canopy ride, the student experienced a hard landing in a corn field.

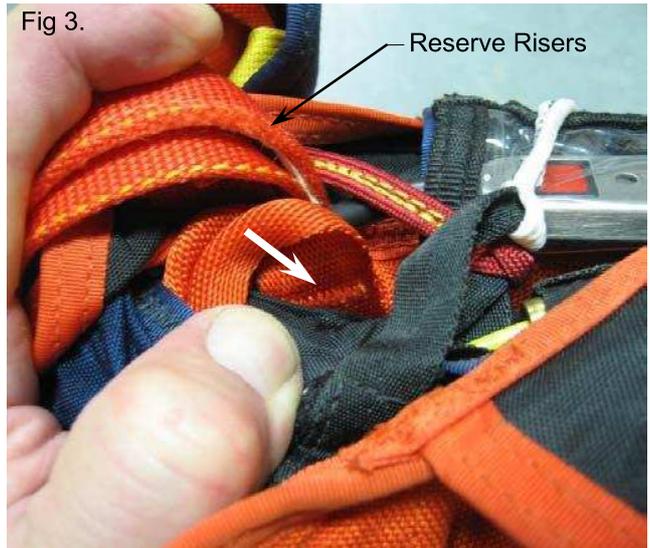
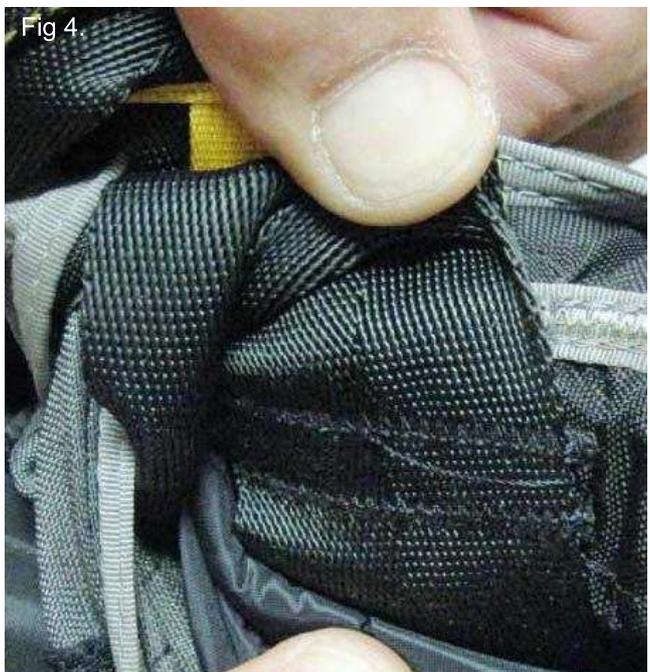
**SERVICE BULLETIN:** Before the next jump it is strongly recommended that all jumpers inspect this area for broken stitching. This can easily be done on packed rigs by simply opening the reserve pin cover and riser cover, then work your thumb up under the diagonal to expose the zigzag stitching. Only the top inside section of stitching needs to be inspected (Figure 3). Consult your local rigger if you are unsure or have any questions.

Figures 3 and 4 show examples of undamaged stitch patterns. Undamaged stitch patterns such as these do not require repair.

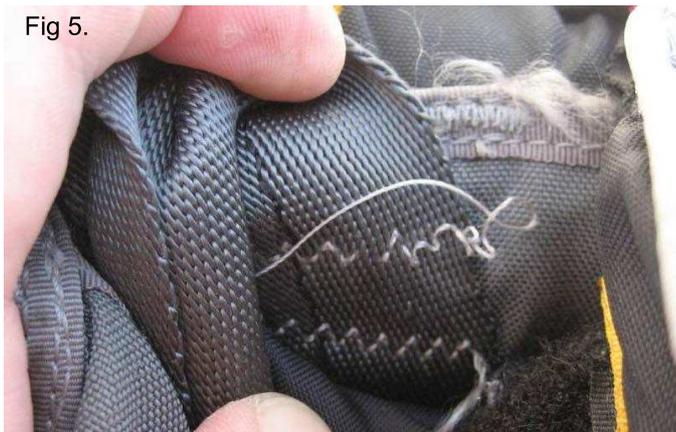
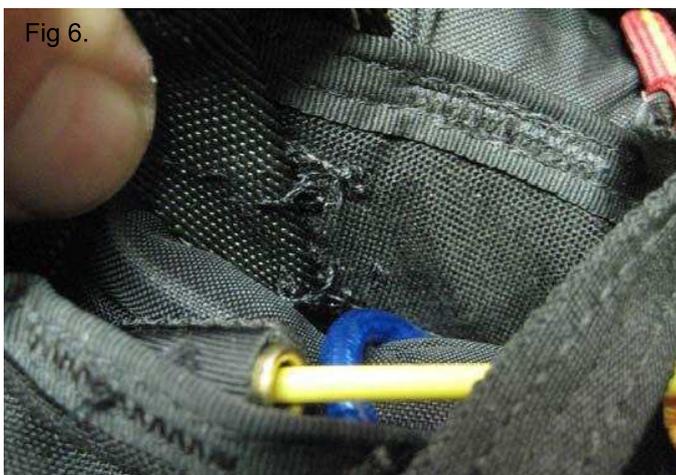
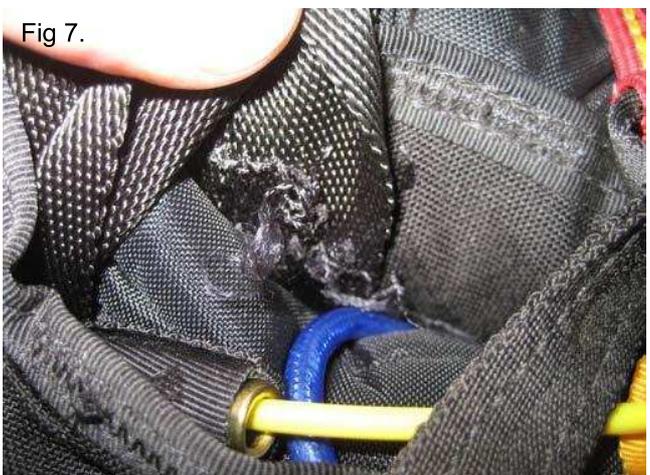
Figures 5, 6 and 7 show example of failing stitch patterns in need of repair.
