SICHERHEITSMITTEILUNG
für Gurtzeuge und Reservefallschirme

Nummer: 01/2012

Safety report bulletin PS 04202012

***RESERVE LOWER STEERING LINES
AND
RESERVE TOGGLES***

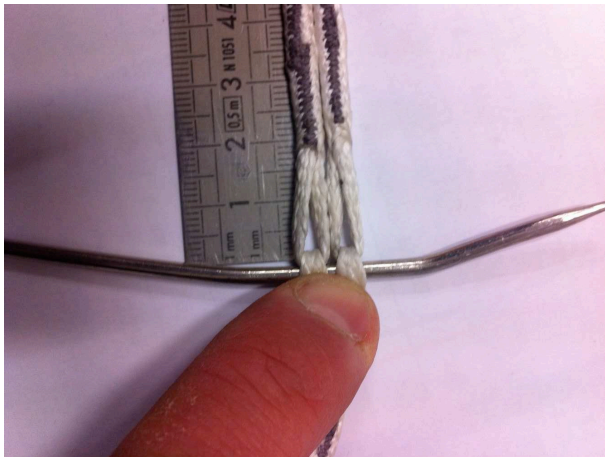
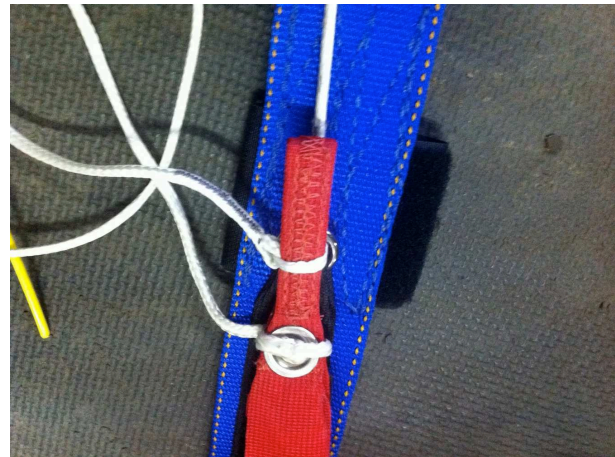
1. Bartack sewing on the right lower steering line is too close to the brake set loop (5mm or 3/16" less than the left one)
2. Toggles nozzle are too soft, implying a nozzle narrowing.
