SICHERHEITSMITTEILUNG
für Gurtzeuge

herausgegeben: 22.06.2012
Nummer: 02/2011

Bezug: **SERVICE BULLETIN von Avasport von 20.06.2012**
Länge Trennkissen

Betroffene Muster: alle Avalon Gurtzeuge

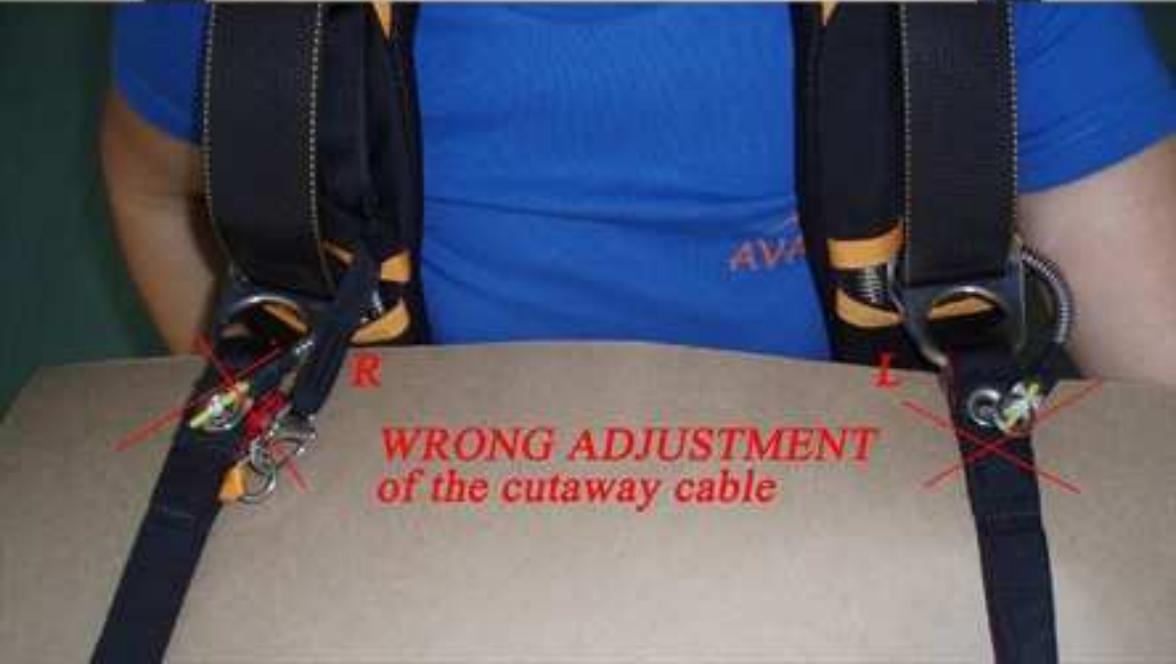
On 17.06.2012 in Moldova after a malfunction of the main canopy the pilot makes a cutaway. The video shows that the right main riser with the RSL split seconds earlier than the left one. This is unusual and abnormal situation. The RSL is equipped with an extra belt and in this case it helped the left riser to cut away and normal reserve opening to be achieved.

We are issuing this AD to detect and correct any incorrectly assembly of the cutaway cables length. This condition if left uncorrected, could lead to wrong rescue opening and twisting of both (main and reserve) canopies.

**WRONG ADJUSTMENT
of the cutaway cable**

1. Put the harness and straighten the main risers.
2. Check the length of the cutaway cables (see the pictures for correct adjustment). The left main riser must be released prior/before the right one with the RSL. That's mean the right cutaway cable (with the RSL) should be longer than the left one.
3. The left main riser must be released 15 mm (½ inch) prior/before the right one with the RSL.
