## SICHERHEITSMITTEILUNG für Gurtzeuge

Nummer: 03/2013

# SERVICE BULLETIN SPSB009

SUBJECT: SUPPLIER/VENDOR RECALL OF PS70104 HOUSINGS (METAL FLEX HOISING INC)

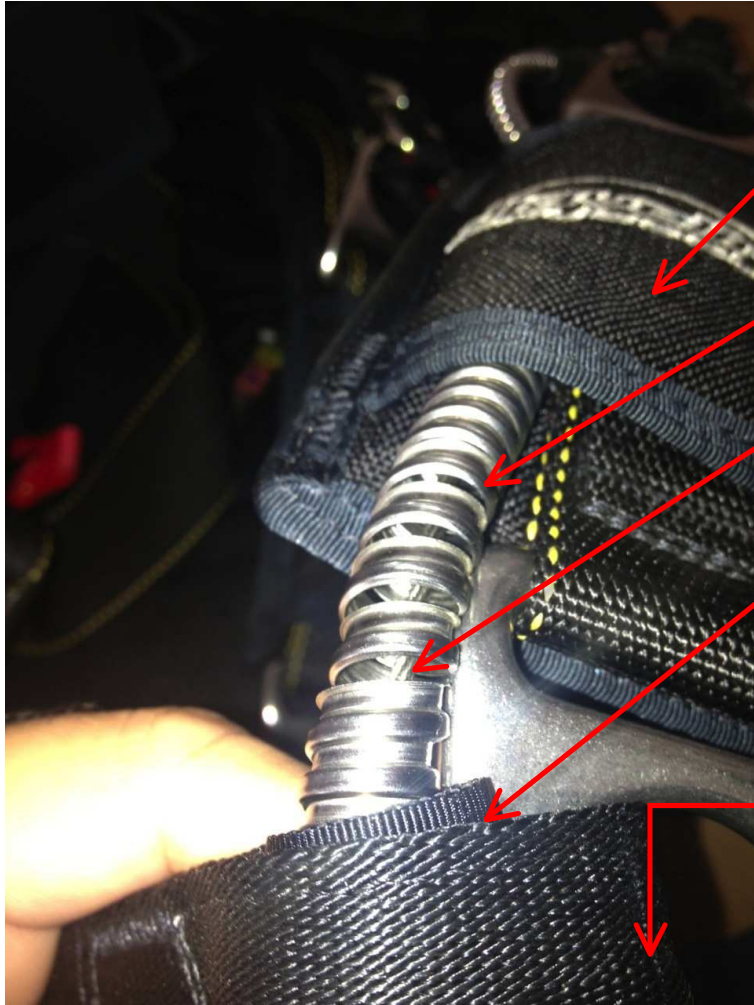
**WEARERS LEFT SIDE:**

SEPERATED HOUSING (FOR REFERENCE)

If the serial number is listed in the above table, inspect the available exposed reserve ripcord housing. Locate the lower end of the housing, which is clamped to the Main Lift Web, just above the reserve ripcord pocket. Inspect the exposed length of housing from the clamp upwards; ensure that the coil has not separated/unraveled. Be sure to inspect the section that is routed through the chest strap.

A. HOUSING FOUND TO BE INTACT (GOOD): The rig may continue to be jumped with periodic monitoring until the next repack cycle or earlier elective replacement. However this housing must be replaced at the next repack cycle. See <http://www.sunpath.com/support/HousingReplacement.pdf> for instructions for your rigger to complete the replacement of the housing.

B. HOUSING FOUND TO BE SEPERATED/UNRAVELLED (BAD): The housing must be replaced before the next jump by a certificated senior or master parachute rigger (or foreign equal) or the manufacturer. See <http://www.sunpath.com/support/HousingReplacement.pdf> for instructions for your rigger to complete the replacement of the housing or instructions to send your system back to the manufacturer.
