SICHERHEITSMITTEILUNG **für Gurtzeuge**

Nummer: 02/2015

PRODUCT SERVICE BULLETIN 2015-01

SUBJECT: EXCESSIVE URETHANE COATING ON SPECTRA RESERVE RIPCORD

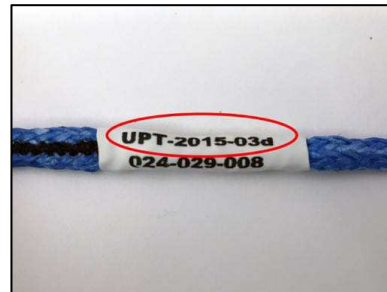
*Locate the white sleeve on the Spectra reserve ripcord.
The top line will read the lot # as "UPT-201X-XXX"*

It has recently come to our attention that some Spectra ripcord cables manufactured in late 2014 and 2015 were coated with the wrong mix of polyurethane and water, possibly resulting in higher pull forces because of increased housing/ripcord friction. While we believe that this affects only ripcords manufactured from December 2014 to May 2015, we are going to consider all 2014 ripcords suspect.

- 1. The interim solution must be accomplished before the next jump on the equipment.**
- 2. The replacement ripcord must be installed at the next scheduled repack, no later than December 31, 2015. After this date, all containers with affected spectra ripcords are grounded until the replacement is made.**

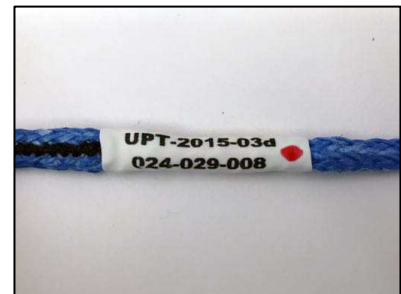
As a reminder use a Sharpie or similar permanent marker, and put a visible dot on the ripcord data sleeve. This will represent the initial treatment performed in June.

When you re-lubricate in July, put a second dot on the backside of the data sleeve, a third in August, and so on, until the replacement can be installed. This will allow any jumper to keep track of the monthly lubrication while the interim solution is in effect.
