## **SICHERHEITSMITTEILUNG** **für Gurtzeuge**

Nummer: 03/2018

Betroffene Muster: Wings-Gurtzeuge mit RSL – Reserve Boost

| Date: 10 October 2018 | Service Bulletin #: 081018 | # of pages: 6 |

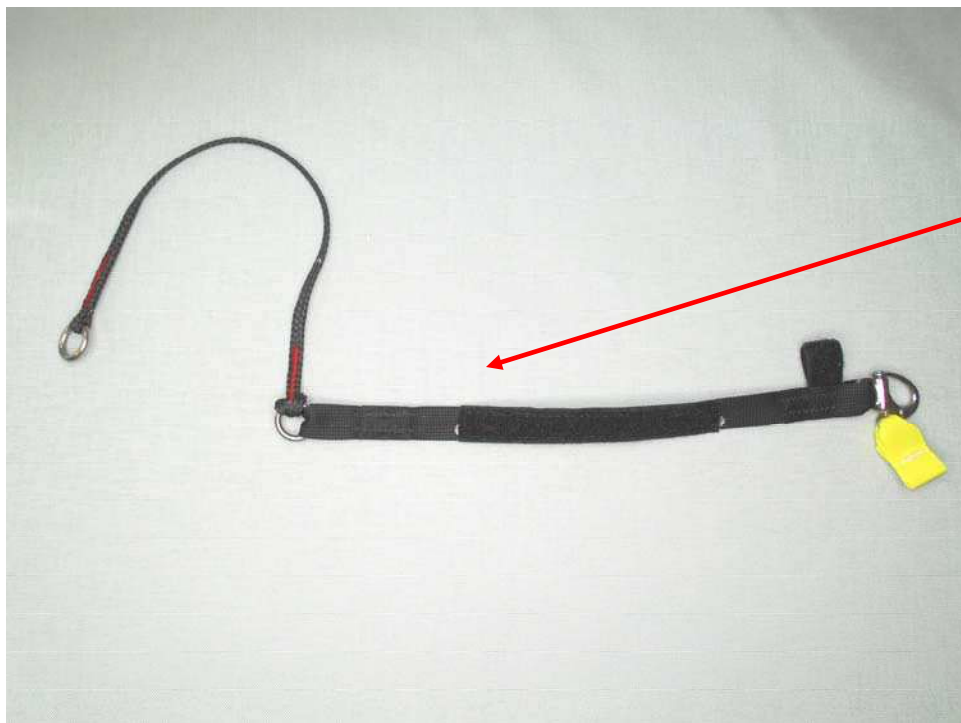
Original RSL for “Reserve Boost” on ***Wings*** Reserve Containers.

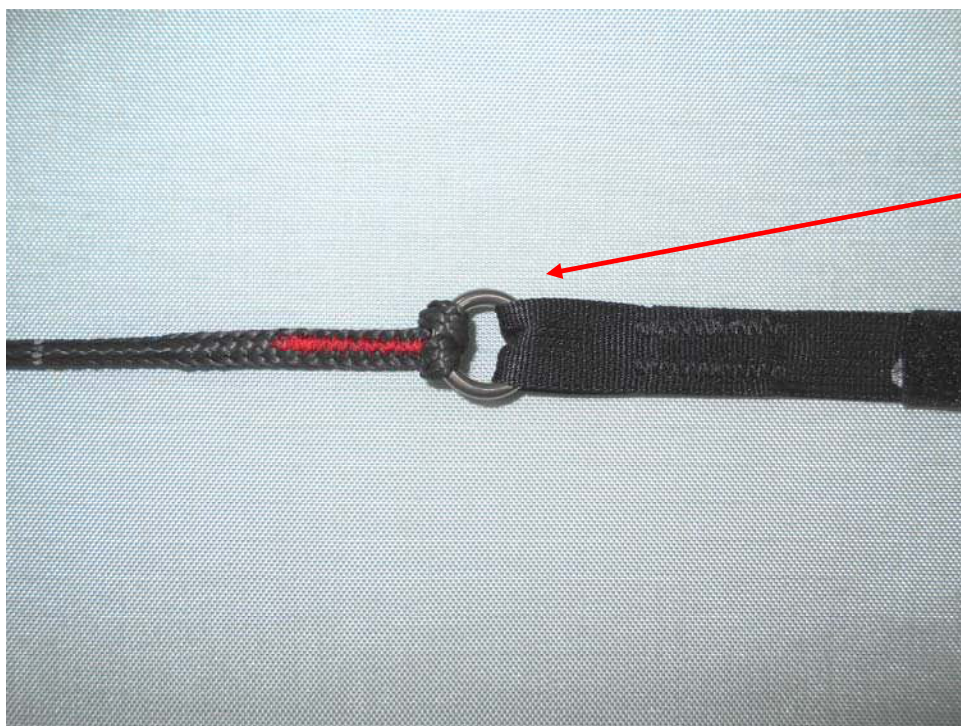
Notice “Lark’s Head” knot on the ring.
