### **Technische Mitteilung**

Nummer: 02/2020

Bezug: Kompatibilität von Originalteilen und Baugruppen nach Vorgaben der Hersteller

**PSB Number:** PSB-10092020

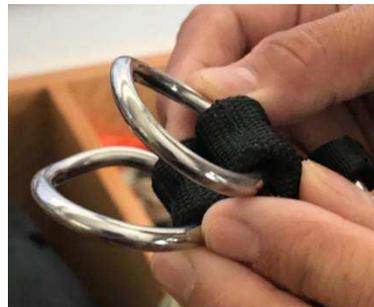
Figure-2

**Background:** Recent reports of “bent rings” on tandem main risers are of great concern. At least one after-market manufacturer of obsolete and unapproved tandem risers is using RW2 rings or similar rings, which were discontinued for tandem use in 1996 due to “bent ring” issues. These rings pass a proof load of 500 lbs. and begin to distort at 2500 lbs.

Two (2) sets of tandem risers were recently discovered with bent rings. This pair bent after one (1) jump; a second pair had approximately 30 jumps.

It should be noted that the RW2 rings themselves are not defective. They simply do not stand up to the rigors of tandem jumping due to the higher tandem weight limits (500 lbs) and the potential for higher airspeeds and harder openings.

**Compliance:** **MANDATORY** – REPLACE BEFORE THE NEXT JUMP.

RW2 rings (or similar size rings) have a cross-section thickness of less than 5mm (0.197"). Risers with these dimensions should be permanently grounded for tandem use.

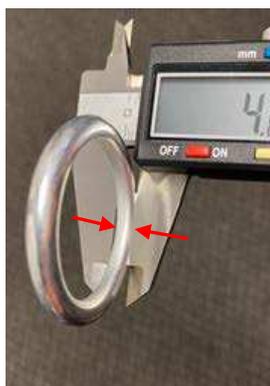
Figure-3

Cross-section Thickness  
RW2 Ring: 4.75mm (0.187")  
RW11 Ring: 5.74mm (0.226")

Use a digital caliper to accurately measure the cross-section thickness of the ring. Refer to *Figure-3* below for proper caliper/ring interface while measuring. The riser should be disconnected from the harness base ring to accurately obtain a measurement.

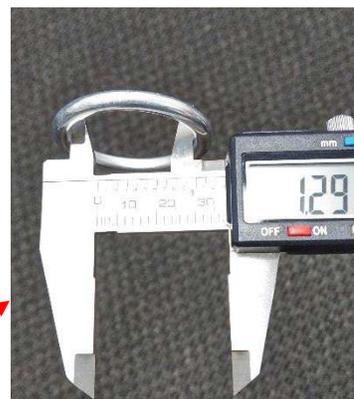
Figure-4

Inner Diameter  
RW2 Ring: 32.9mm (1.30")  
RW11 Ring: 31.0mm (1.22")

The inner diameter ring dimensions are also provided (*Figure-4*) as further verification of the ring type.
