SICHERHEITSMITTEILUNG für Gurtzeuge

herausgegeben: 2021-Febr. 09
Nummer: 2021-01

Bezug: Bulletin Instruct 064 Rev 0 Vector V3SE Reserve Pin Cover Field
Modification

VECTOR 3SE RESERVE PIN COVER FIELD MODIFICATION

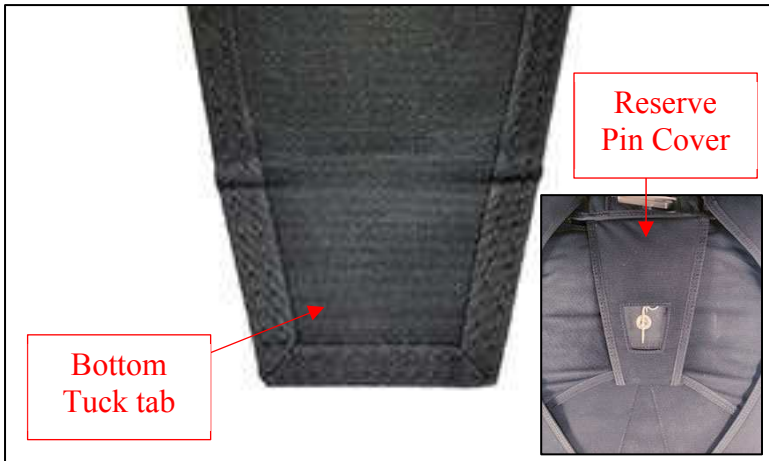
Identify the Reserve Pin Cover flap bottom "Tuck Tab".
