## SICHERHEITSMITTEILUNG für Gurtzeuge

- herausgegeben: 2021-09-15
- Nummer: 04 / 2021 Firebird Gurtzeuge verstellbarer Hauptgurt
- Bezug: PSB FB 2021-01 vom 15.Sept. 2021
- Betroffene Muster: EVO - Gurtzeuge der Firma Firebird , **alle Muster**  
Omega, Student, V1R1 Evo und Tandem **mit verstellbarem Hauptgurt**

Bulletin Number: FB 2021-01

SUBJECT: Firebird V1R1 EVO Harness container systems with adjustable Main Lift Web

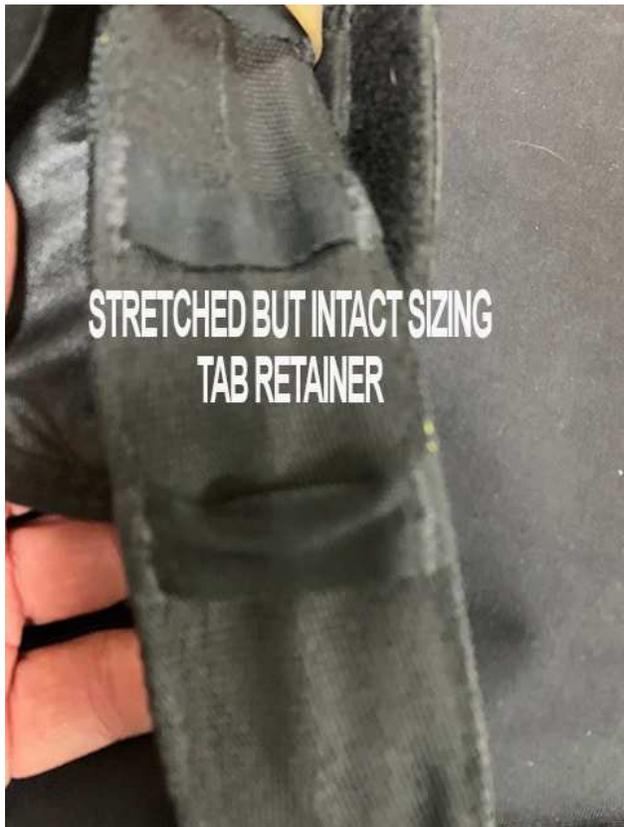
**Right** Main lift web undone, sizing safety tab ripped off and stuck under a stretched but intact sizing tab retainer (1/2" type 1), 555-2 ring installed **correctly**, **missing** spring, **NO** damage to type 4 stopper.

From the stretch marks of the sizing tab retainer, we think that the misrouting happened not too long ago by a third party during the rental process and that it went unnoticed for an unknown period by anyone involved in the rental process and handling of the container.

**Stretched tab retainer**

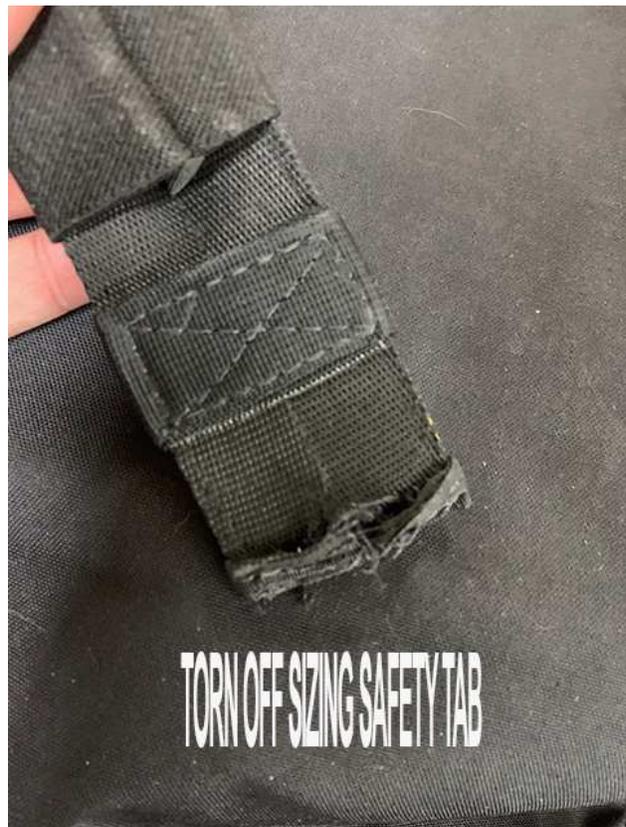
In this incident, it appears that, the only thing that kept the webbing from coming undone, was the engaged sizing safety tab in the type 1 sizing tab retainer and that it subsequently broke under the load of the opening as **zero** damage to any other component occurred.

The right main lift web of the affected container that came undone does **not** show any damage on the type 4 stopper with only the sizing safety tab torn off and matches only the findings of at least one configuration of those simulations carried out by Firebird.

**Torn off tab, damage free type 4**

To make sure that in the future only qualified Riggers can disassemble the main lift web, we strongly recommend replacing the type 4 stopper with four layers of type 17 webbing and sew a BOX X pattern with at least 5-cord. Firebird USA LLC uses exclusively 6-cord.

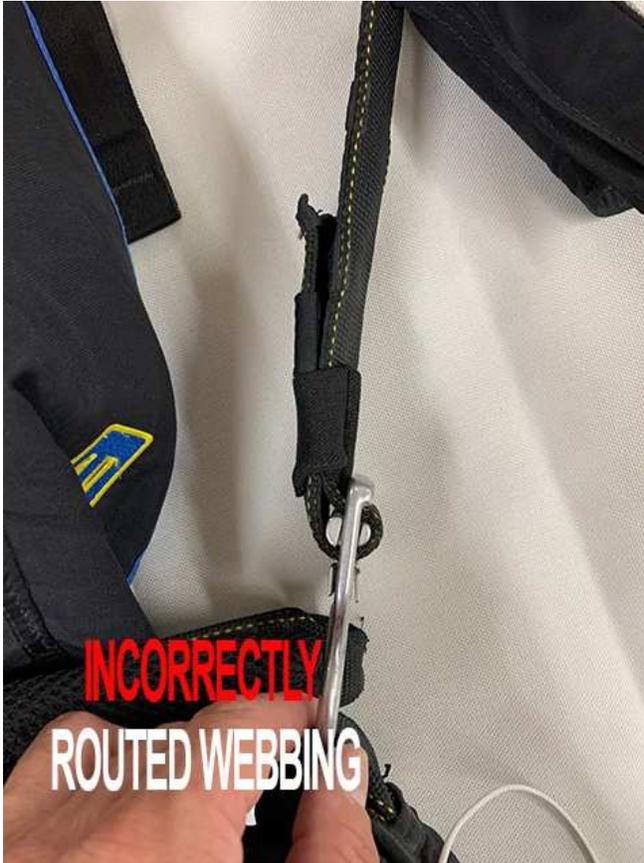
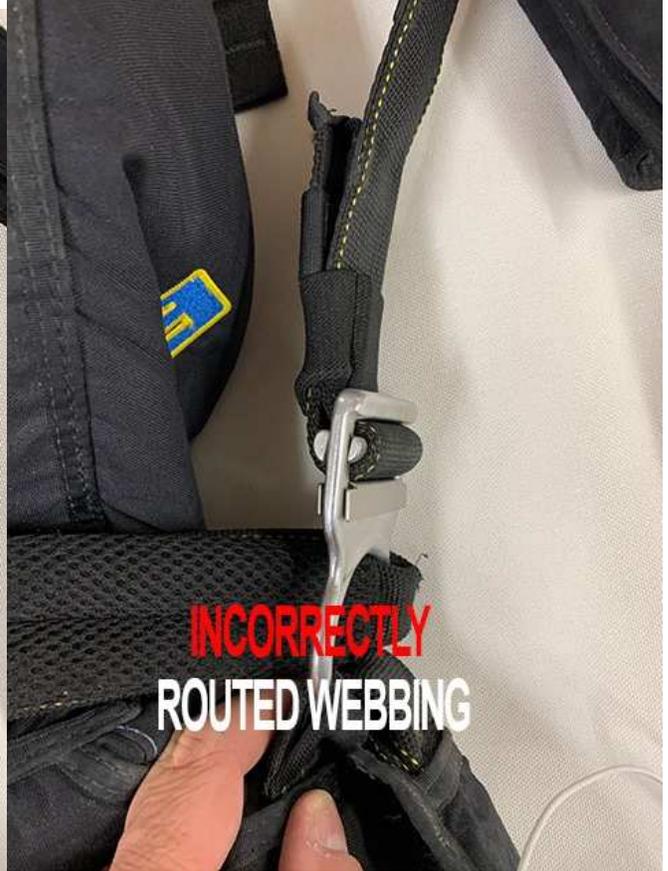
## INCORRECT ROUTING PRESENT ON EVO 8611-172

**Left** Main lift web threaded **incorrectly** (double routing, wrong direction, see pics), sizing safety tab attached with only a few stitches (69tex/E thread) ripped, sizing tab retainer stretched but intact, 552-2 ring installed **correctly**, spring present, **NO** damage to type 4 stopper.

The incorrectly routed webbing on the **left** side strongly indicates that, the **right** side that came undone, most likely also had been routed incorrectly.

*Incorrectly routed webbing will result in a slippage towards the open end and in opposite direction of the engineered purpose as the friction lock will not properly engage and not properly block the webbing from slipping.*

The configuration of the incorrectly **double** routed configuration as present on the left side of the container, showed a torn off sizing safety tab **and** ripped type 4 stopper in **all** simulations at around 2000 lbs.

Therefore, we mandate a visually inspection before the next jump, to confirm the correct routing of the adjustable main lift web through a type 555-2 ring (DJA/CWH) especially if the container has been disassembled for repairs, maintenance, cleaning, or any other reason. All direct customers have been contacted by Firebird USA LLC.

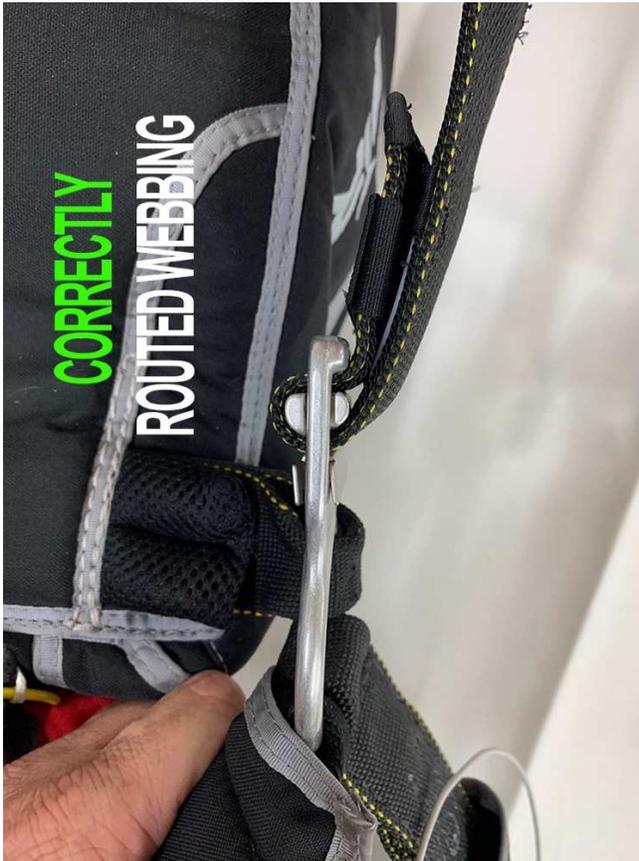
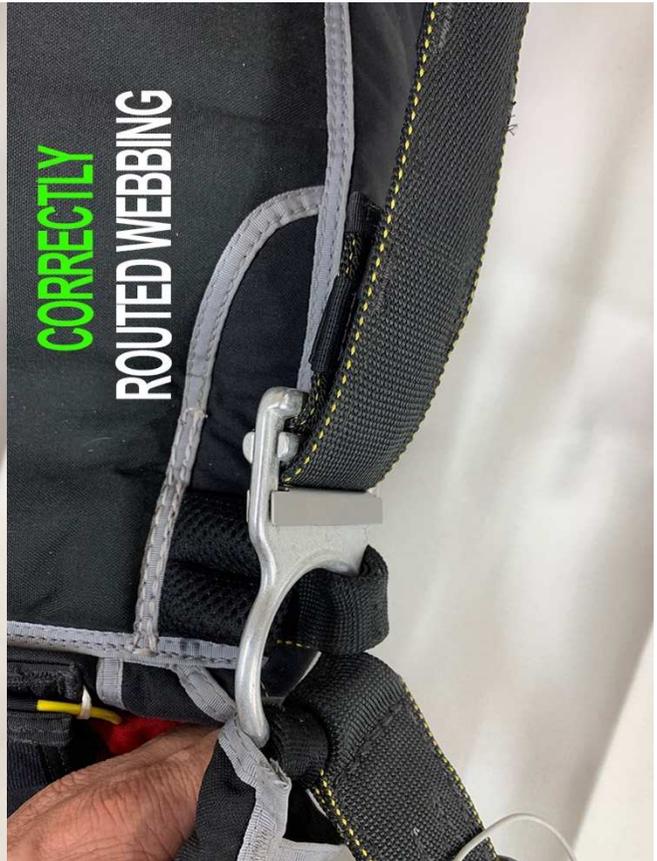
!!!! CORRECT ROUTING !!!!

Correctly routed webbing, **regardless** of the ring direction, showed **zero** slippage or damage.

Always inspect the correct routing of the main lift web before use, especially if the harness-container is in a rental, demo or student setting or was recently in maintenance.
