## **SICHERHEITSMITTEILUNG** **für Gurtzeuge**

Nummer: 2026-05 SM Paraworld – Sife - Klappe Rev. 1

## Service Bulletin 2023-001 Revision 1

**Subject: bar tack/zig zag stitching on main container flap #2**

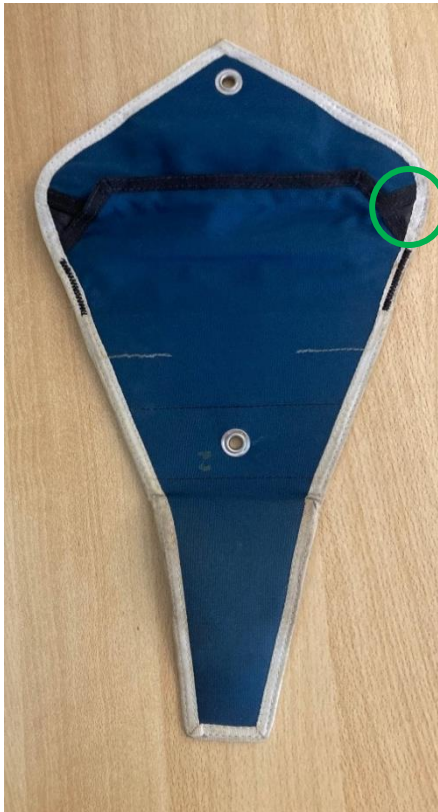
- the main pilot chute was a self-made one and smaller than the original SIFE main pilot chute
- the main pilot chute had 468 jumps on it (SIFE recommends changing the main pilot chute after 400 jumps at the latest)
- the flap #2 was damaged and bent
- the material and the stitching between the green circle were weak

Probably during the main canopy opening, the main pilot chute did not have enough power to pull the main canopy correctly out of the container. The lines slipped up over the reserve container and came to rest at flap #2. As the material and the stitching had already softened after 1500 jumps, a line could get caught.

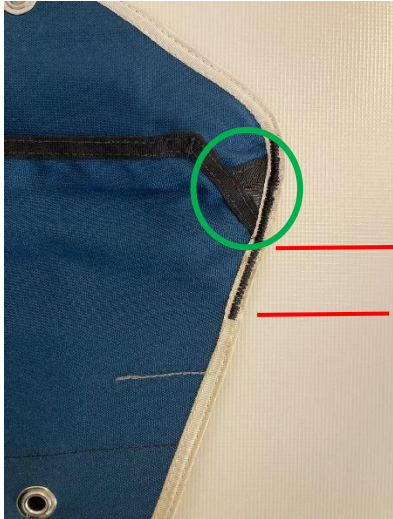
The flap #2 is stiff in the area between the two bindings (green circle on the picture above), when your SIFE rig comes out of production because of a stiff material and a stitching under the bindings. If the material and/or the stitching under the bindings are weak after many jumps (green circle in the picture above), overstitch this area also with bar tacks/zick-zack stitching (minimum 10 stitches per inch, 3mm wide).

The result is a stitching, which begins over the first binding and ends at the beginning of the stiffener. The result of the stitching is a stiff flap in this area.

Check the stitching and the material of the flap #2 (between red lines and green circle) on each reserve repack.
