PIA Technical Bulletin TB-301

Parachute Industry Association Publications March 02, 2000

Container Grommets and Small Suspension Lines

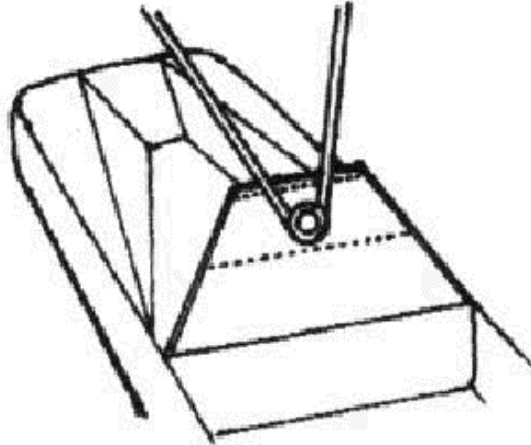
Because of two recent fatalities involving relatively small suspension lines snagging on container grommets, as well as other similar incidents not resulting in fatalities, the PIA Technical Committee recommends:

Figure 1 -
Suspension-line snagged around improperly seated container flap grommet.

1) All container grommets should be inspected to ensure that they are properly set See figure 1.

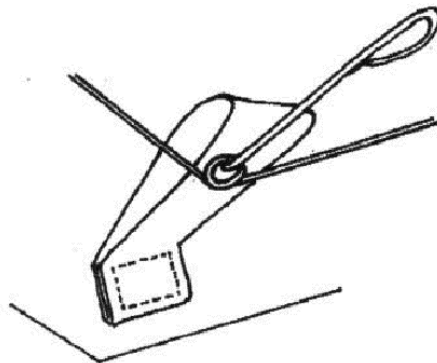
Figure 2
Suspension line snagged around grommet on main loop anchor

2) On main containers with a "main closing loop webbing anchor", users / riggers should contact the manufacturer for their current recommendations. See Figures 2 and 3.

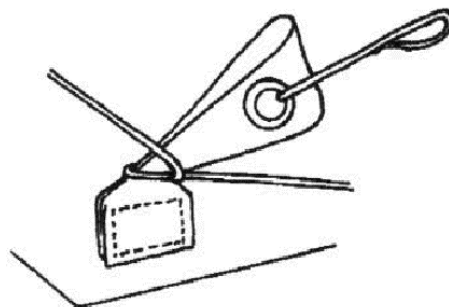
Figure 3
Suspension line half-hitched about main loop anchor
