TECHNICAL & SAFETY COMMITTEE

INTERNATIONAL PARACHUTING COMMISSION (FAI)

Technical & Safety Information Notice No.	01/2009	W.N. 22
Date of Issue	28 January 2009	
Subject Matter and Applicability	<p>Following a riser failure on a PA Talon, the Australian Parachute Federation's Director Rigging, Jo Chitty, issued the following notice. This notice is of mandatory status for APF members, and it is being distributed by the Technical & Safety Committee of IPC to alert skydivers worldwide to the issues concerned.</p> <hr/> <p style="text-align: center;">IMPORTANT ANNOUNCEMENT FROM THE DIRECTOR OF RIGGING, AUSTRALIAN PARACHUTE FEDERATION. MANDATORY INSPECTION OF ALL 3-RINGS PRIOR TO NEXT USE</p> <p>RISER FAILURE On Sunday 18 January 2009, a PA Talon riser failed on opening. It was the left riser with RSL fitted. The reserve was deployed into the trailing main by the RSL resulting in a main reserve entanglement. Fortunately and with luck the jumper managed to attain sufficient reserve inflation to survive the landing with broken bones in his back and shoulder.</p> <p>During the investigation of his equipment it was found that the 3-ring closing loop had pulled out from under the confluence

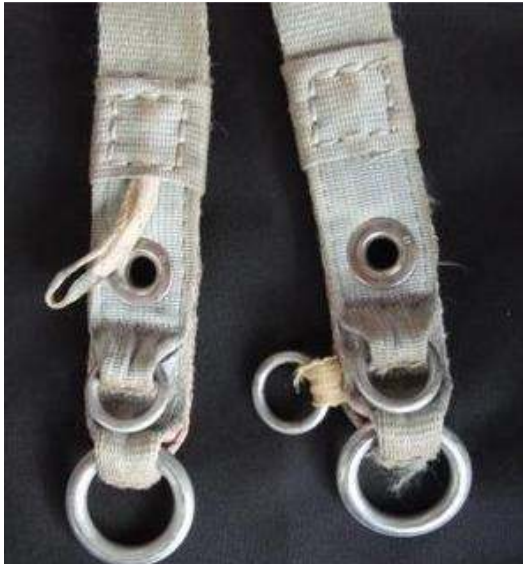
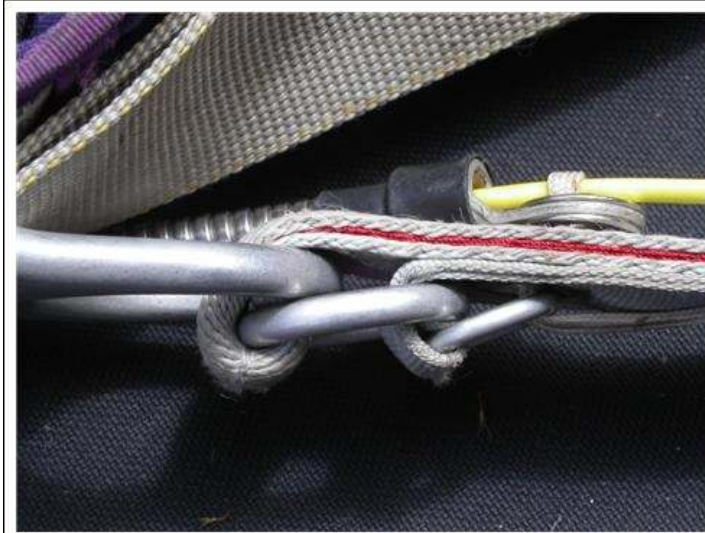
In August 2001 the APF promulgated APF Service Bulletin No APF010801-A 3-ring Inspection And Maintenance. The inspection, Part A, is designated **Mandatory**. This rig's reserve had been packed six times since the service bulletin was published, and numerous other times when the main was packed and possibly the 3-rings serviced. Had the service bulletin been applied it would have highlighted that the riser did not meet the criteria of the service bulletin; **the locking loop was too short.**

Due to the unique method of construction on this riser of bar-tacking across the loop it is probable that over a period of jumps some of the stitches had broken, due to the excessive load applied by the short locking loop until on this jump they failed completely allowing the loop to pull out of the riser, releasing it. It is impossible to visually inspect the stitching as it is covered by the confluence wrap; failure comes without warning signs. There was no kink in the left cutaway cable to warn of excessive loading. To prevent a similar event occurring especially when an RSL is fitted the following must occur.

MANDATORY INSPECTION in accordance with APF Service Bulletin [APF010801-B](#)* Issued 23rd January 2009 of all 3-ring riser assemblies before the next jump. Inspection to be noted on reserve packing card and marked on inside of front riser with APF010801-B using a fine tip paint pen so it will be visible even if the risers are black.
