Issued by: Sächsische Spezialkonfektion GmbH
Nordstr. 40
02782 Seifhennersdorf
GERMANY

Subject: Pilot Chute at Emergency Parachutes,
Type RE-5L, Seria 4 und 5, (LBA.040.010/89 JTSO)
Manufact.-No.: 72245 – 72371, except 72370
Manufact. Date: 21.04. – 21.08.2008 (Date of EASA
Form 1)

Enclosure to SAFETY BULLETIN No. 01/2008

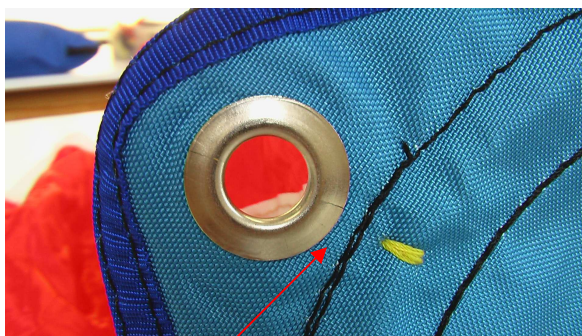
Fig. 2: Grommet

Reason: Pilot chutes as part of Emergency Parachutes RE-5L,
produced and delivered in-between the above mentioned
period, may have damaged (chapped) grommets at the top
(see Fig. 2).
In extreme case it may happen an obstruction of the closing
loop by a damaged grommet and further on the proper
opening of the parachute container may be obstructed.

Tear

Requested action: Replacement of Pilot Chute at all Emergency Parachutes RE-5L with the Manufacturing-No's 72245 – 72371, except 72370, produced and delivered in-between the period 21.04. – 21.08.2008 (Date of EASA Form 1)

- ***Scope of work:***
 - Opening the hand-made securing stitch an the connecting point Pilot Chute – Connecting Line
 - Replacing the Pilot chute
 - Set the hand-made securing stitch between the Pilot Chute and the Connecting Line by using sewing yarn Nm 11/3
 - Confirming the action by signing in the Parachute Log-Book (page 10) with following Text: *Safety Bulletin SPEKON 01/2008 realized*
 - Re-sending the replaced Pilot Chute to SPEKON
- Contacts at SPEKON for all question around the Safety Bulletin are:
 - Harald Wilhelm Tel. 03586 456 145 wilhelm@spekon.com
 - Jens Thumeyer Tel. 03586 456 124 thumeyer@spekon.com
 - Ilona Christoph Tel. 03586 456 146 christoph@spekon.com
