UNINSURED UNITED PARACHUTE TECHNOLOGIES, LLC.

SERVICE BULLETIN #20110523

SUBJECT: Inspection of the top diagonal attachment point on all Vector 3 Sport and SE Student Harness/Container Systems.

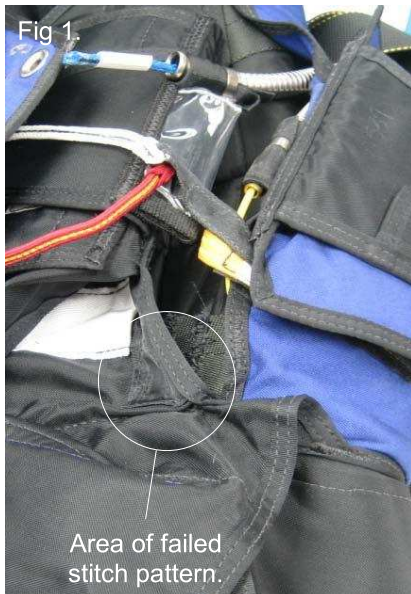
BACKGROUND: It was reported that a student jumper after pulling at a planned altitude of 5000', experienced a very hard opening and broke the upper double zigzag stitching that holds the diagonals in place and tore most of the ring cover off (See Fig1). This allowed the large ring riser attachment to be pulled far away from its normal position, deforming the over the shoulder section of padding and in turn pulled the RSL lanyard releasing the reserve pilot chute.

NOTE: It is unlikely this stitch pattern failed completely on this one jump, but was damaged on other prior jumps and completely failed on this one very hard opening. Further inspection of other Vector SE containers at the same DZ revealed other diagonals with various stages of stitch failure in need of repair.

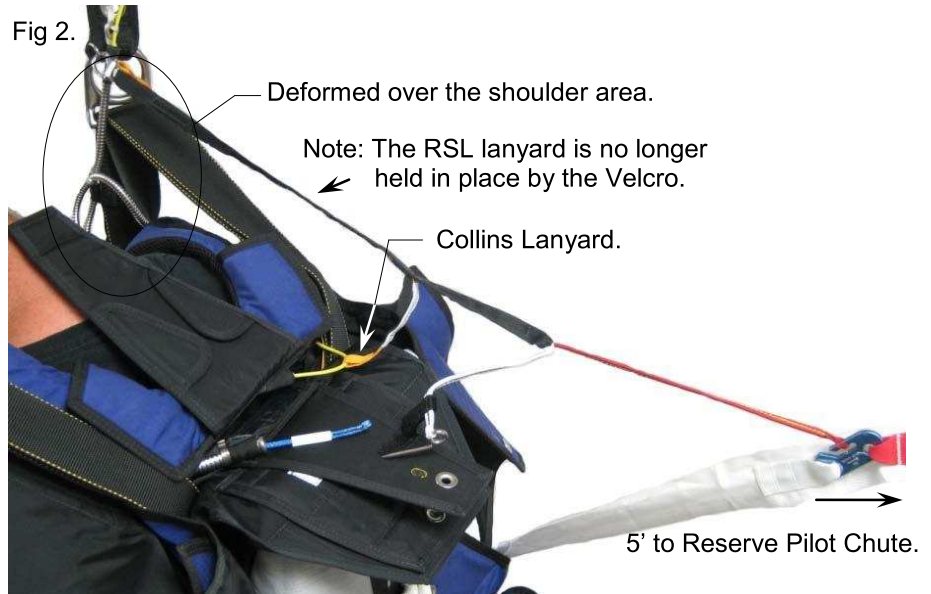
At an altitude of around 4500' the attachment point of the SkyHook and RSL lanyard produced a trailing reserve pilot chute (preventing a two out scenario) as witnessed from the ground (See Fig2). At an altitude reported to be between 225' and 250' the student jumper initiated a final approach turn, but due to the deformation of the right shoulder section of the harness, the Collins lanyard released the left riser from this turn input (See Fig2). The student then reacted by immediately pulling the cutaway handle releasing the right riser initiating a SkyHook direct bag deployment. After a very short reserve canopy ride, the student experienced a hard landing in a corn field.

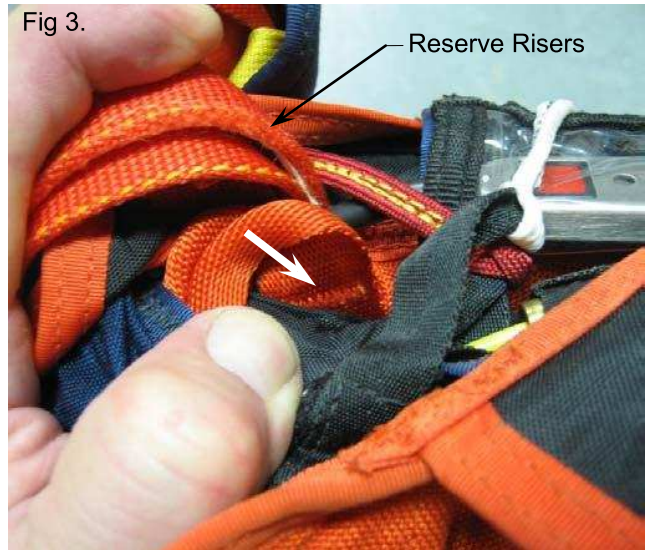
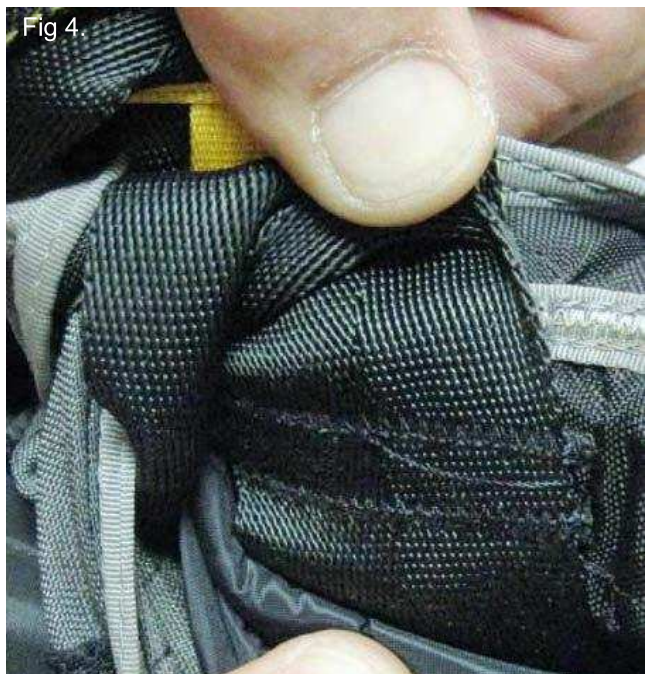
Figures 3 and 4 show examples of undamaged stitch patterns. Undamaged stitch patterns such as these do not require repair.

SERVICE BULLETIN: Before the next jump it is strongly recommended that all jumpers inspect this area for broken stitching. This can easily be done on packed rigs by simply opening the reserve pin cover and riser cover, then work your thumb up under the diagonal to expose the zigzag stitching. Only the top inside section of stitching needs to be inspected (Figure 3). Consult your local rigger if you are unsure or have any questions.

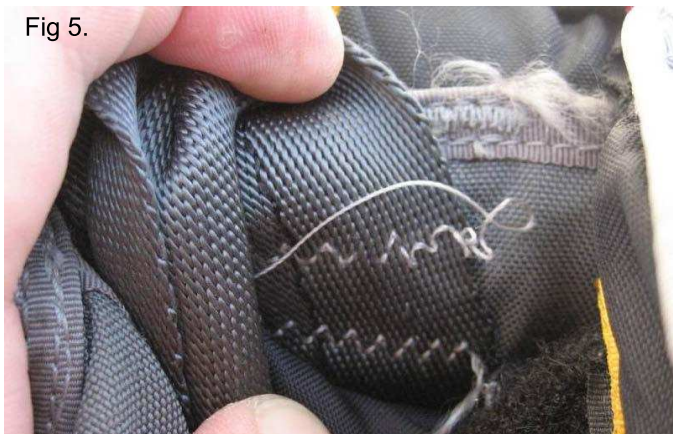
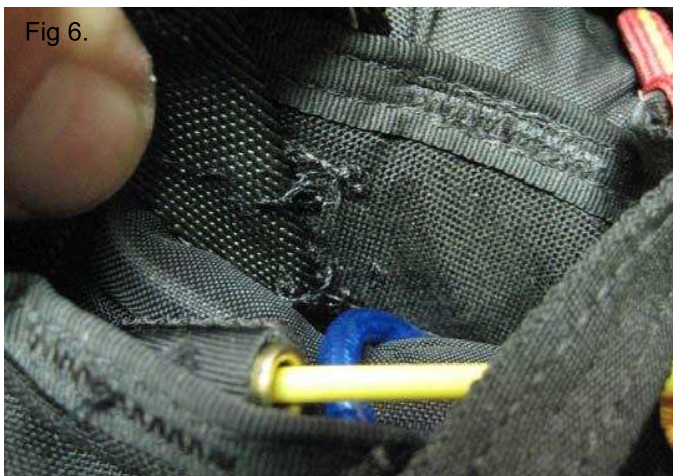
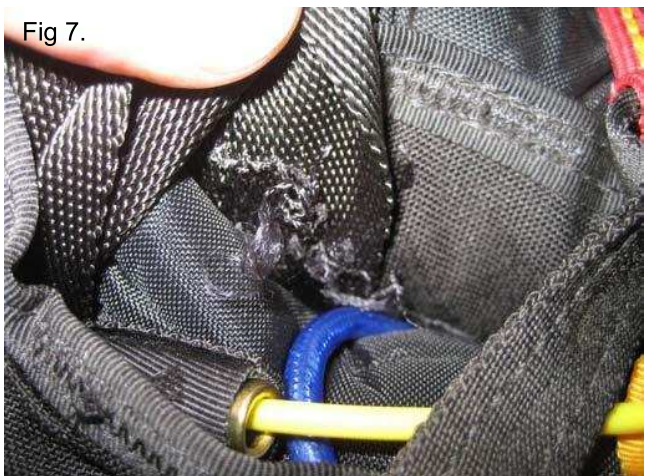
Figures 5, 6 and 7 show example of failing stitch patterns in need of repair.

If the diagonals are in need of repair, riggers in the field are now authorized and requested to make this zigzag repair using “E” shape stitch pattern. This “E” shape zigzag stitch pattern is the same pattern that has been in use on the Sigma Tandem system for some time.
