SERVICE BULLETIN VSESB001

SERVICE BULLETIN VSESB001, REV 0

SUBJECT: MAIN RISER, LOCKING LOOP WEAR

STATUS: MANDATORY INSPECTION

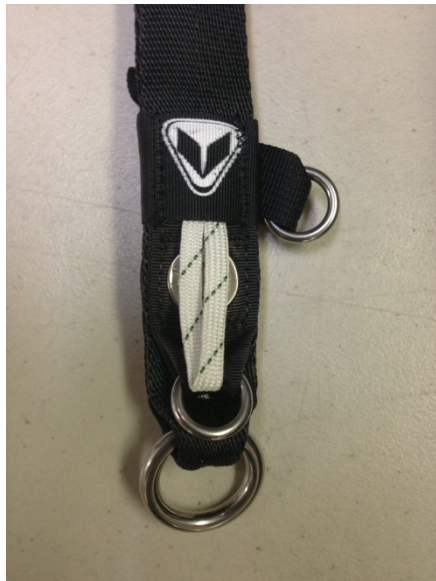
Figure 3: New Locking Loop

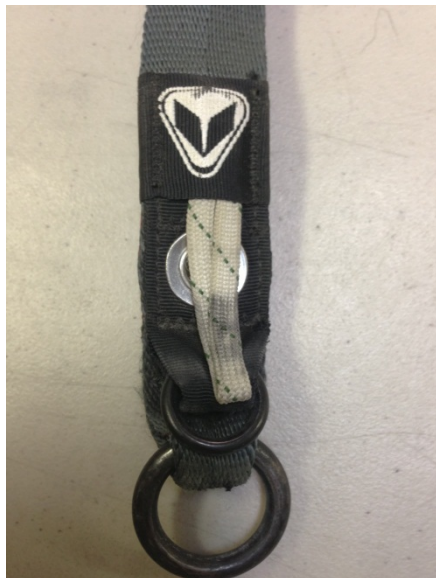
Figure 3: Normal Wear, Front

If the loop shows normal wear, the rig can continue to be jumped and no immediate repair is needed.

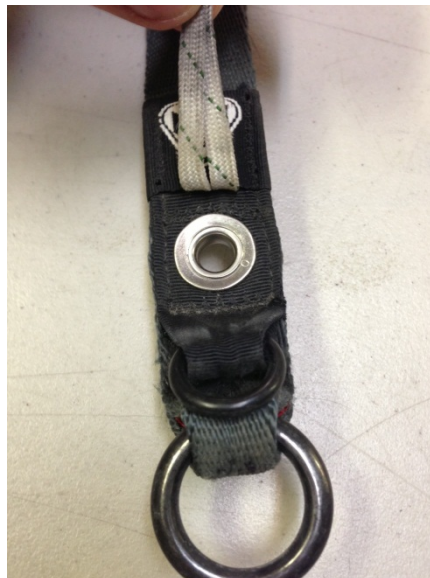
Figure 4: Normal Wear, Back

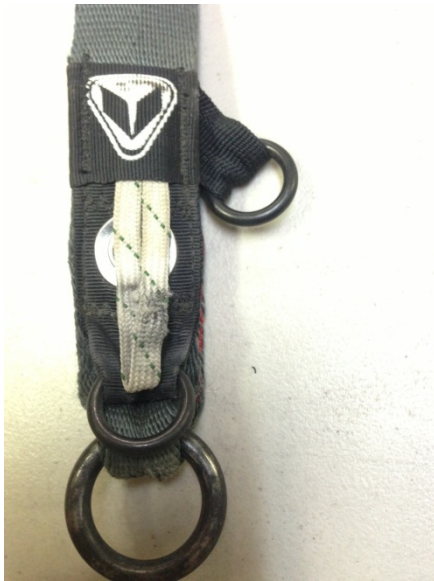
The following pictures show locking loops with damage; heavily frayed and partially cut.

Figure 5: Damaged, Frayed

If the loop shows signs of damage, the rig should not be jumped and VSE should be contacted for further instructions. VSE may also ask for additional information to help determine the root cause and most effective repair. At minimum, VSE will need 2-4 photos, one of each riser loop and one of each housing grommet. Please have these available to send to VSE when you call in. In most cases, once the root cause is determined, VSE will provide a parts kit which can be installed by an FAA certified senior or master parachute rigger or foreign equivalent using the Housing Replacement Procedure provided at the end of this service bulletin. In certain cases, VSE will require the rig be returned to VSE for further inspection and repair.

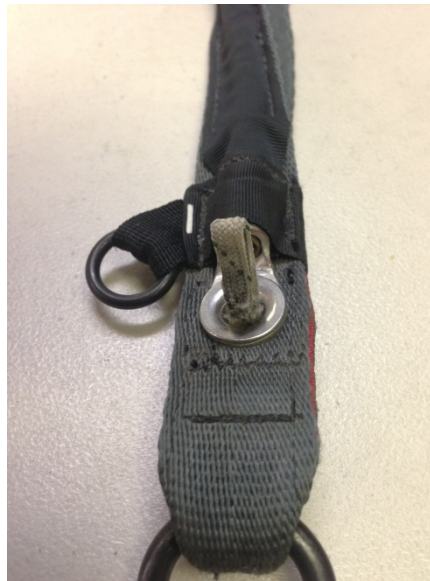
Figure 6: Damaged, Frayed

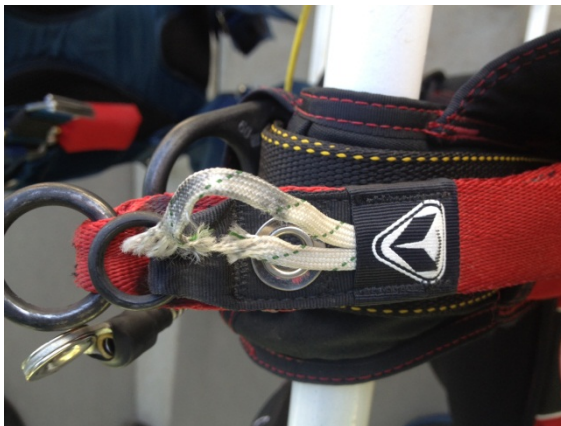
Figure 9: Damaged, Partially Cut

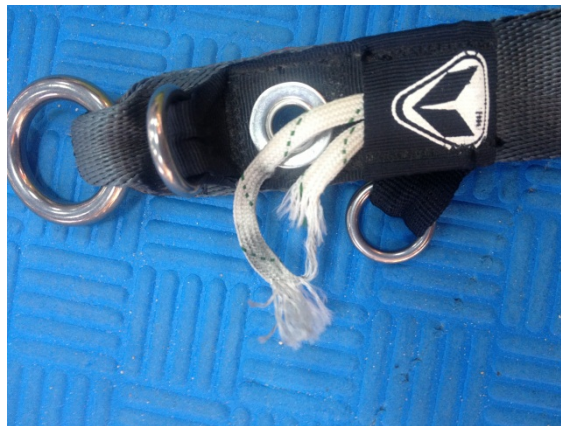
Figure 10: Damaged, Partially Cut
