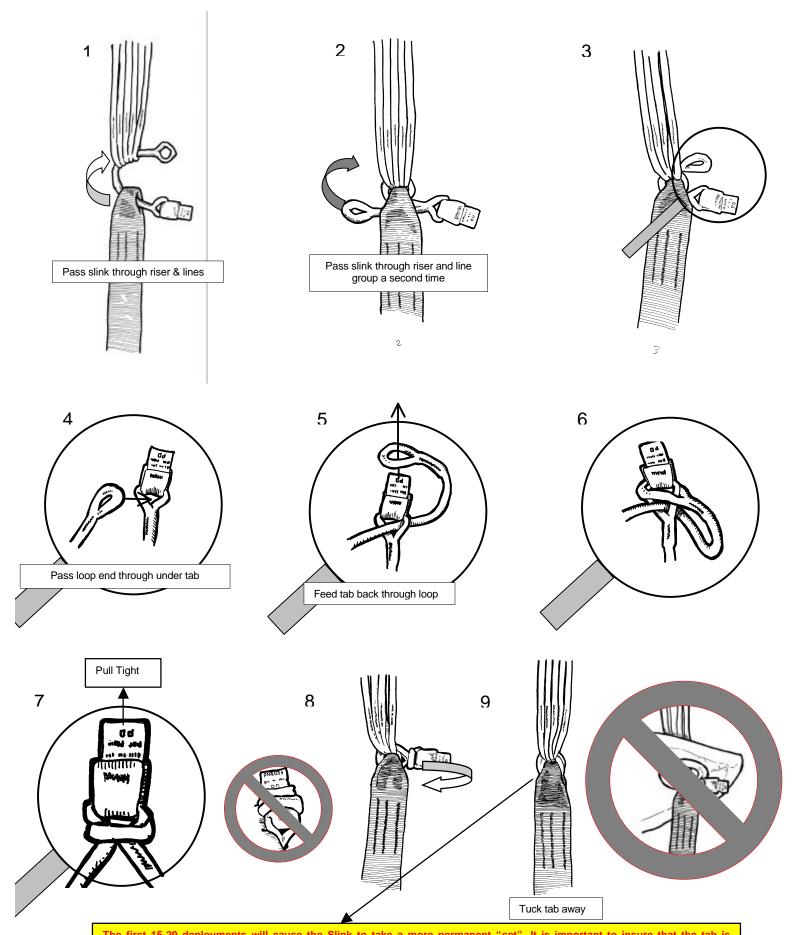
The first 15-20 deployments will cause the Slink to take a more permanent "set". It is important to insure that the tab is located between the risers during this period so as to insure this set occurs with the tab in the proper position. Once this has occurred, the Slink will have a tendency to remain in this position.

If this procedure is not followed, the tab may rotate out of position. Allowing the tab to remain outside of the risers during deployment and flight will result in excessive wear of the Slink, potentially leading to a structural failure.
