**SICHERHEITSMITTEILUNG**  
**für Sprungfallschirme**

- Gültig ab: 25.07.2003
- Nummer: 04/2003
- Bezug: Herstellerbulletin # SP 02
- Betroffenes Muster: Alle Javelin- und Javelin Odyssey-Gurtzeuge mit Verstellharness (meist Schülergurtzeuge).

## Number SP02

## Service Bulletin **SP03 – Adjustable Main Lift Web Harnesses**

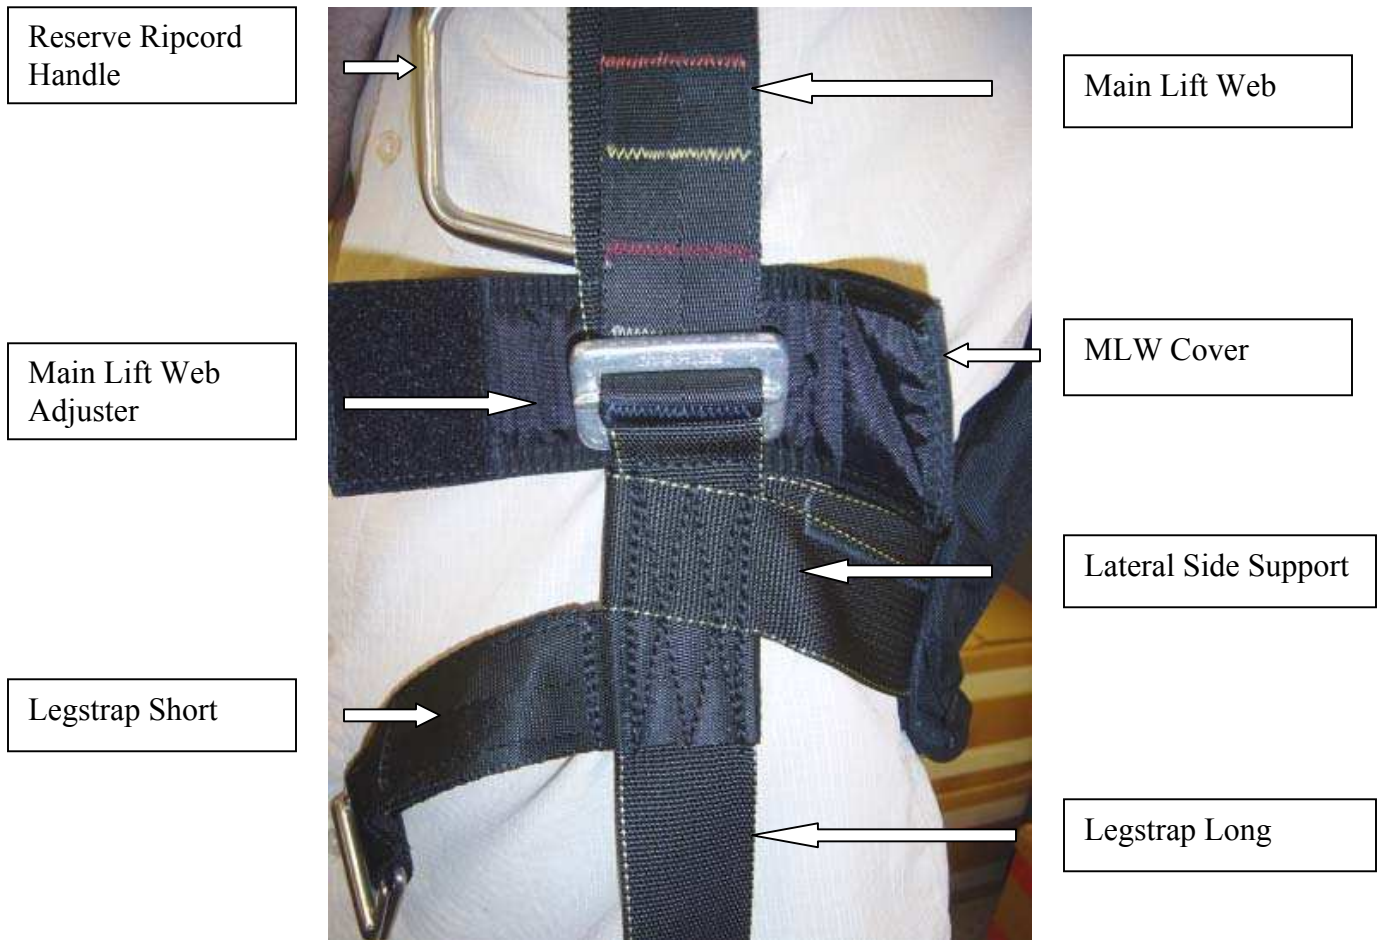
Description of Identification (View shown is “ Wearer’s Left “)

**Identification:** All Adjustable Main Lift Web Harnesses on Javelin and Javelin Odyssey harness/container systems, the majority being Student Systems. The Main Lift Webs (MLW) on the left and right side are threaded through adapters mounted just above the junction of the legstrap and lateral side supports. The Adjusters are primarily used for sizing of the MLW to better fit the user during use.

**Inspection Requirement:** The webbing securing the adjuster in place at the junction of the legstrap and lateral side supports is to be inspected for wear and tear. If the webbing shows signs of fraying or abrasion that is inconsistent or appears to be excessive with what would be termed “normal wear”, the harness/container system is to be grounded and Sun Path Products, Inc. is to be contacted for further action

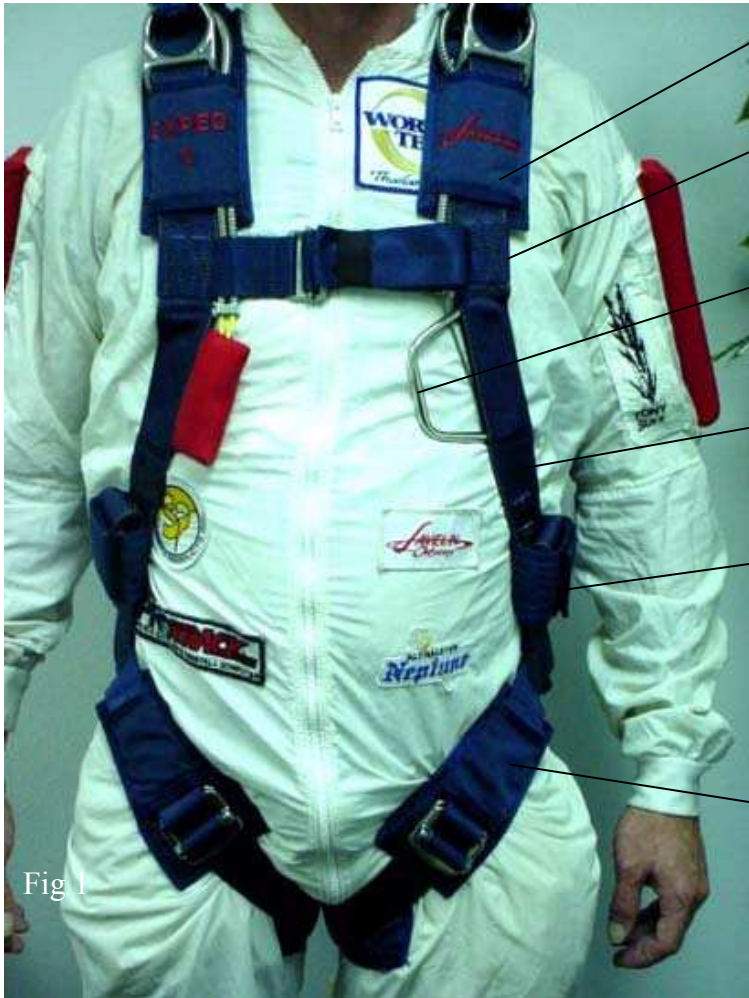
Fig 1

Javelin Student and Student Odyssey with Adjustable Main Lift Webs. See Fig 1. TSO Label Identification as per - Part No 101 A-ADJ, B-ADJ or C-ADJ, see Fig 2. All dates of manufacture up to and including July 19, 2004 are affected.

LRC - Left  
Ring Cover

Cheststrap

Reserve  
Ripcord Handle

Main Adjustable  
Lift Web - Left

Main Lift Web  
Adjuster under Cover  
Refer to Fig E1 below  
for Detail

Legstrap  
Left

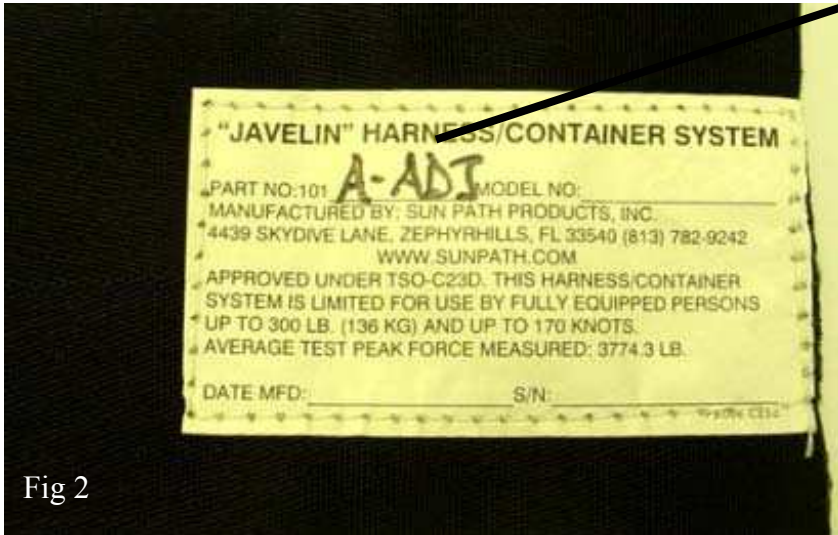
Fig 2

Part Number

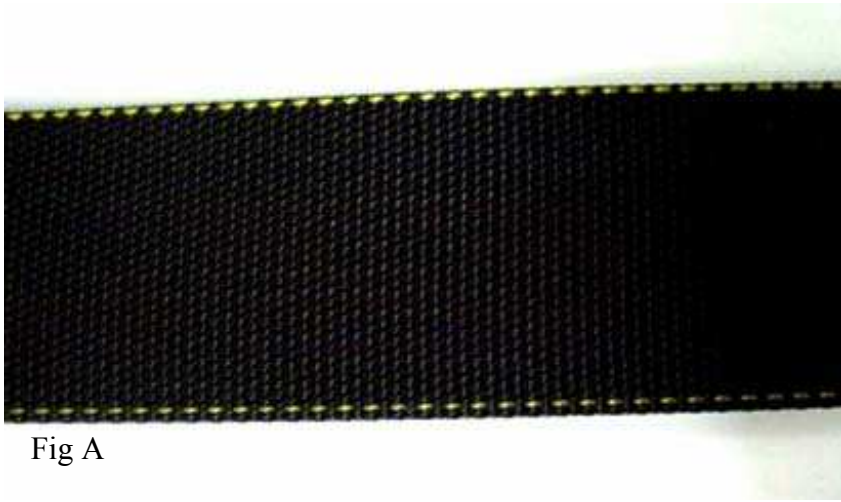
Fig A

- “1” - Like New – see fig A.
- “2” – Minor Hook & Loop type abrasion. Minor abrasion from normal use similar to that of legstrap webbing through a friction adapter – see fig B.
- “3” – Any selvedge damage at all to any harness webbing - see fig C.  
Missing or broken harness stitching - see fig D.  
Any loosening or stretching of the lower connection point webbing which would allow the friction adapter to rotate – see fig E1 & E2.  
Any damaged hardware, sharp edges or other deformities that may be considered a cause for the damage in this grade level.

Grade 1

- (c) If the finding of the inspection in paragraph (a) receives a grading of “1” or “2”, the Harness Inspection Record must be submitted to Sun Path Products, Inc. prior to the system being returned to service.

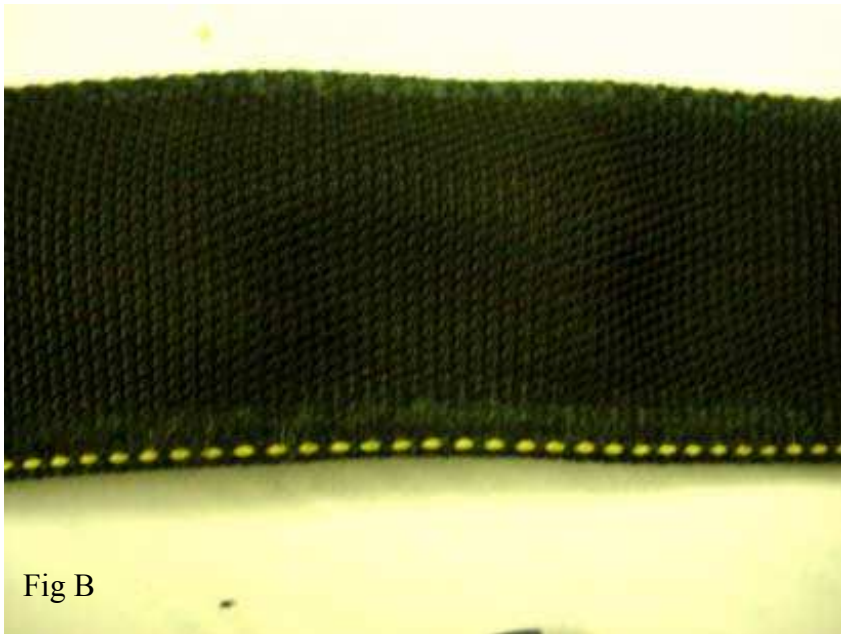
Fig B

Grade 2

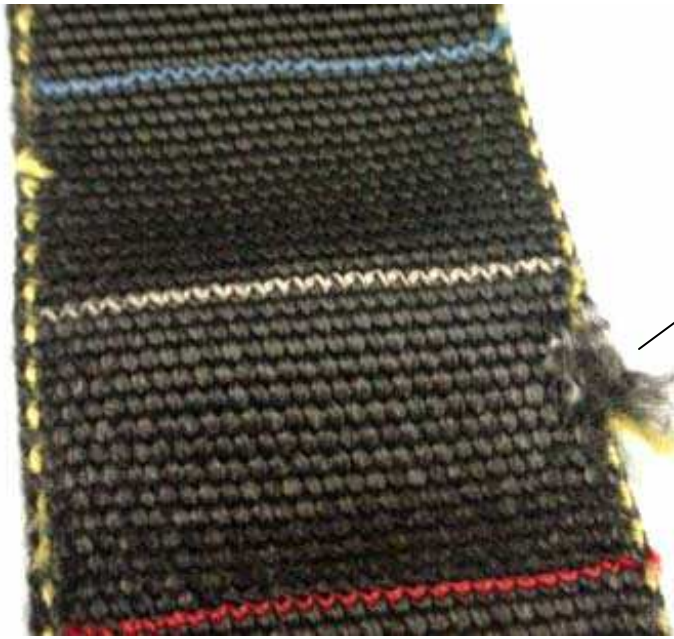
Fig C

Grade 3

- (d) If the finding of the inspection in paragraph (a) receives a grading of “3”, the harness/container system is to be removed from service immediately. The Harness Inspection Record must be submitted to Sun Path Products, Inc. prior to the affected harness sections and /or hardware pieces being replaced and the system re-certified airworthy.

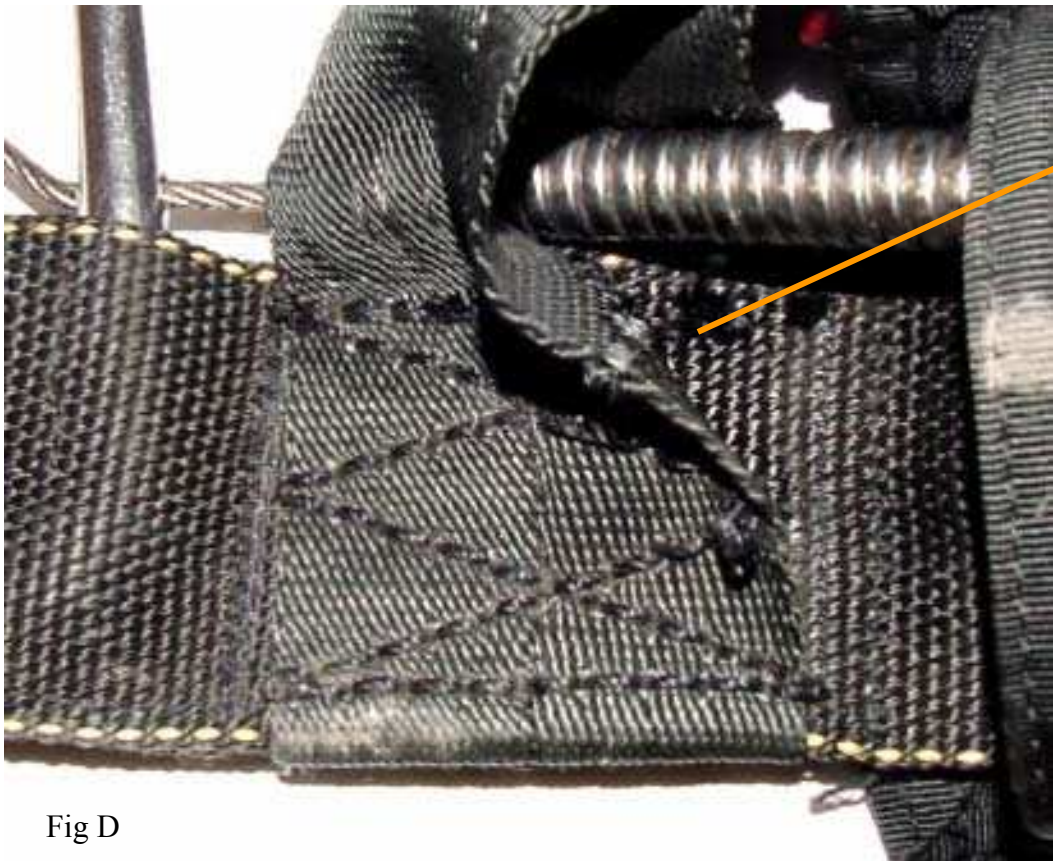
Fig D

Grade 3

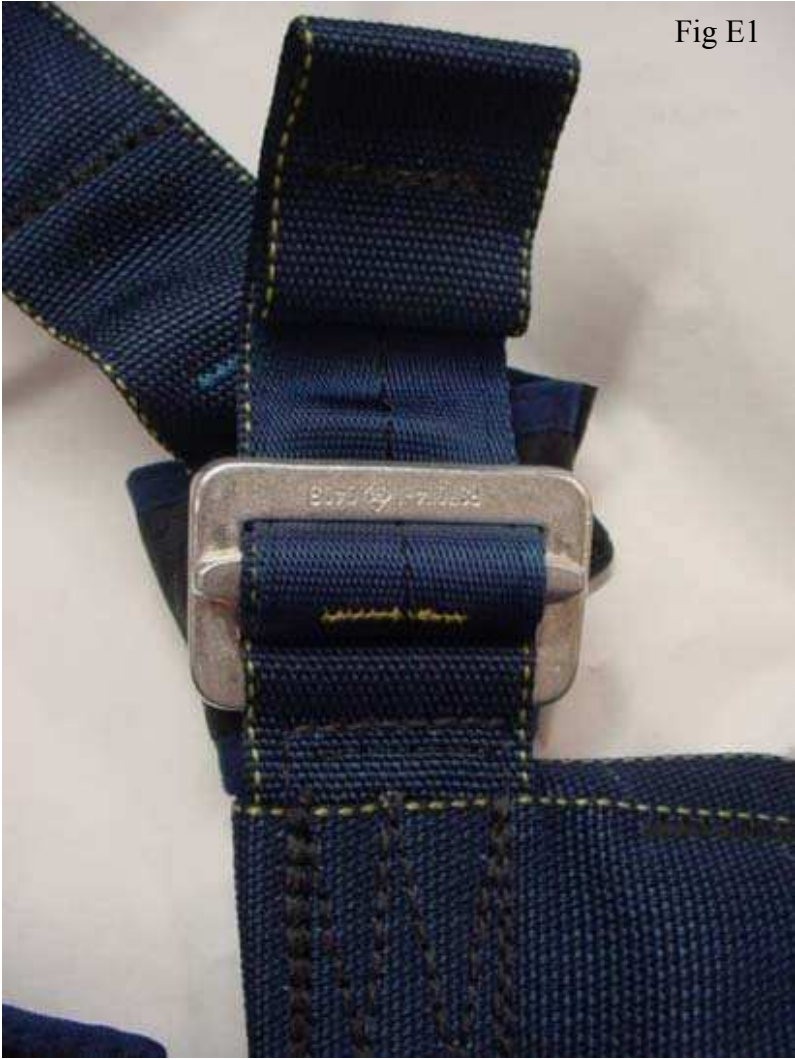
Fig E1

Grade 1- Hardware secured by webbing

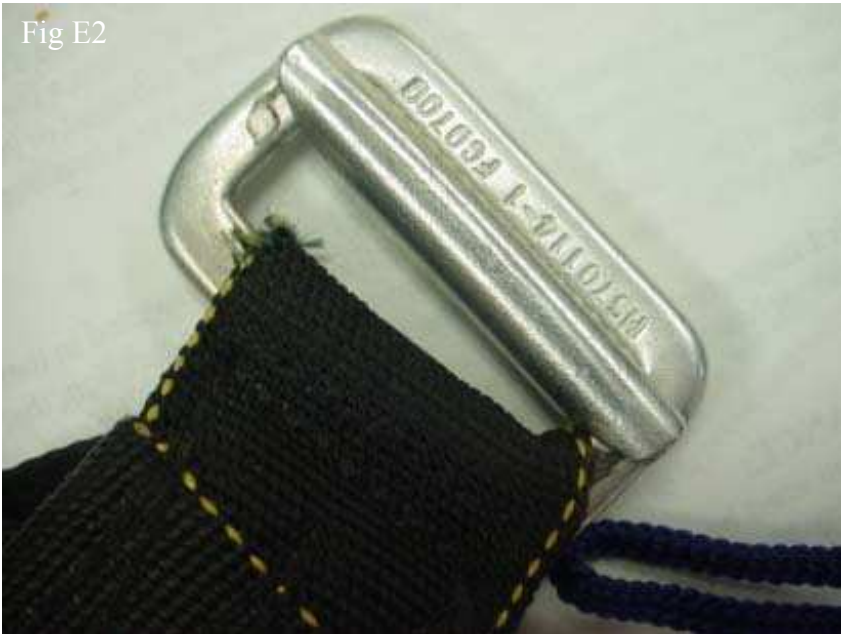
Fig E2

Grade 3 - Hardware able to rotate and/or selvedge damaged

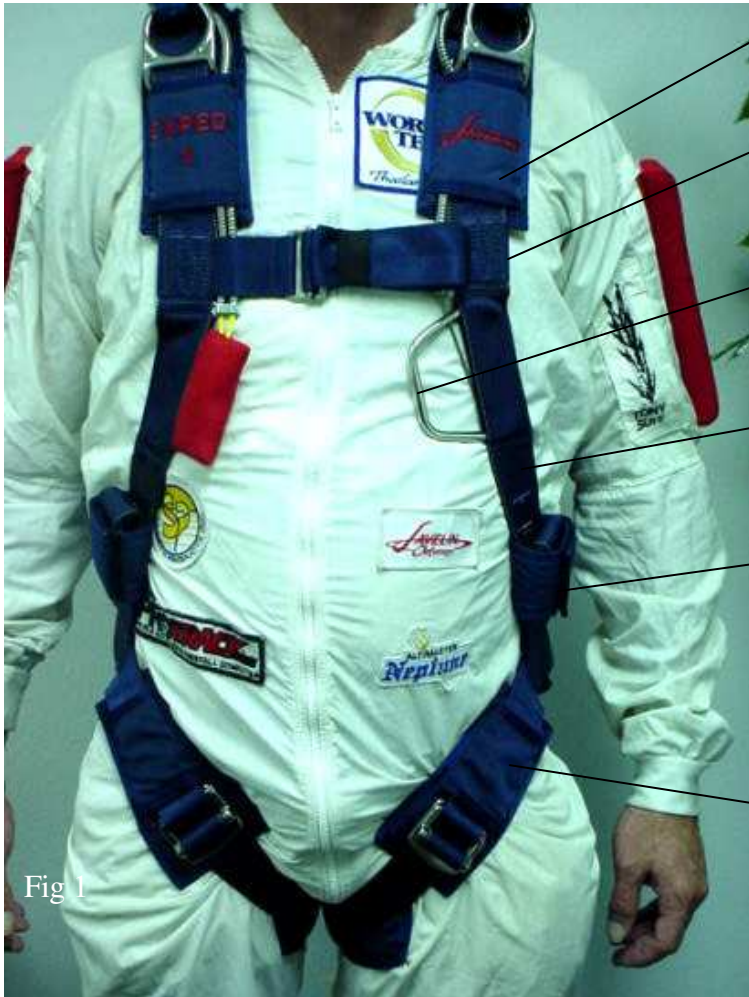
Fig 1

Javelin Student and Student Odyssey with Adjustable Main Lift Webs. See Fig 1. TSO Label Identification as per - Part No 101 A-ADJ, B-ADJ or C-ADJ, see Fig 2. All dates of manufacture up to and including July 19, 2004 are affected.

LRC - Left Ring Cover

Cheststrap

Reserve Ripcord Handle

Main Adjustable Lift Web - Left

Main Lift Web Adjuster under Cover Refer to Fig E1 below for Detail

Legstrap Left

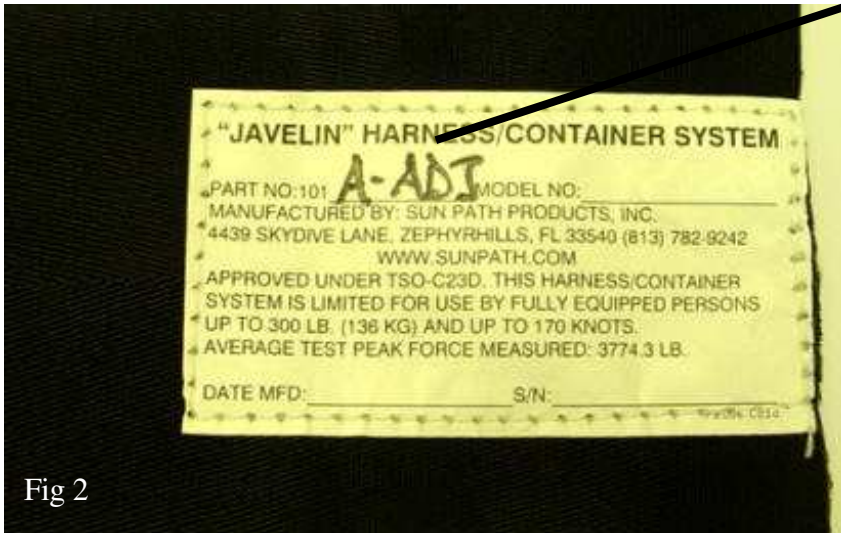
Fig 2

Part Number

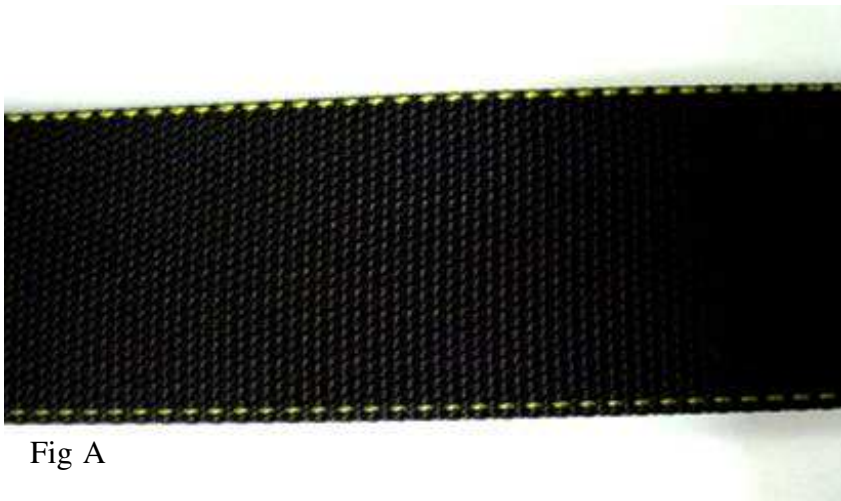
Fig A

- “1” - Like New – see fig A.
- “2” – Minor Hook & Loop type abrasion. Minor abrasion from normal use similar to that of legstrap webbing through a friction adapter – see fig B.
- “3” – Any selvage damage at all to any harness webbing - see fig C.  
Missing or broken harness stitching - see fig D.  
Any loosening or stretching of the lower connection point webbing which would allow the friction adapter to rotate – see fig E1 & E2.  
Any damaged hardware, sharp edges or other deformities that may be considered a cause for the damage in this grade level.

Grade 1

- (c) If the finding of the inspection in paragraph (a) receives a grading of “1” or “2”, the Harness Inspection Record must be submitted to Sun Path Products, Inc. prior to the system being returned to service.

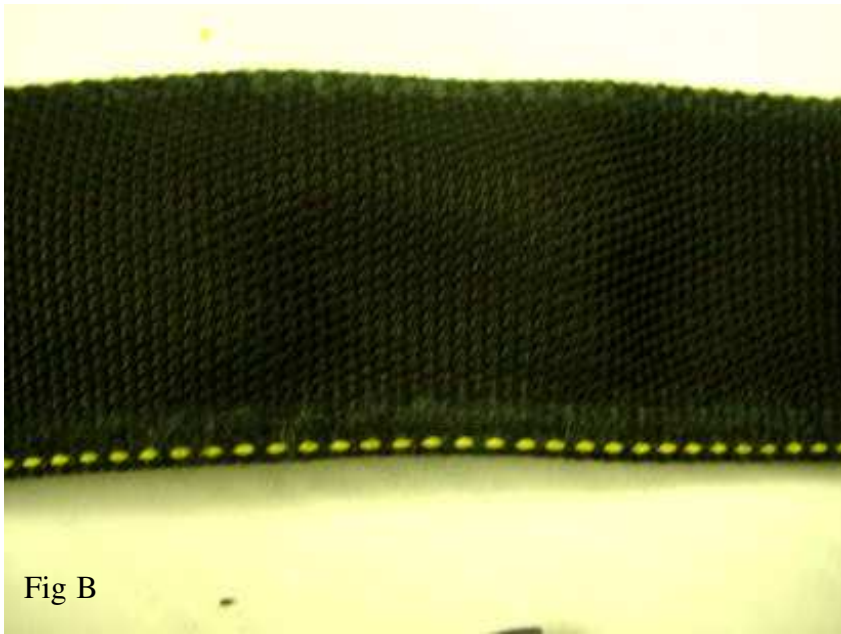
Fig B

Grade 2

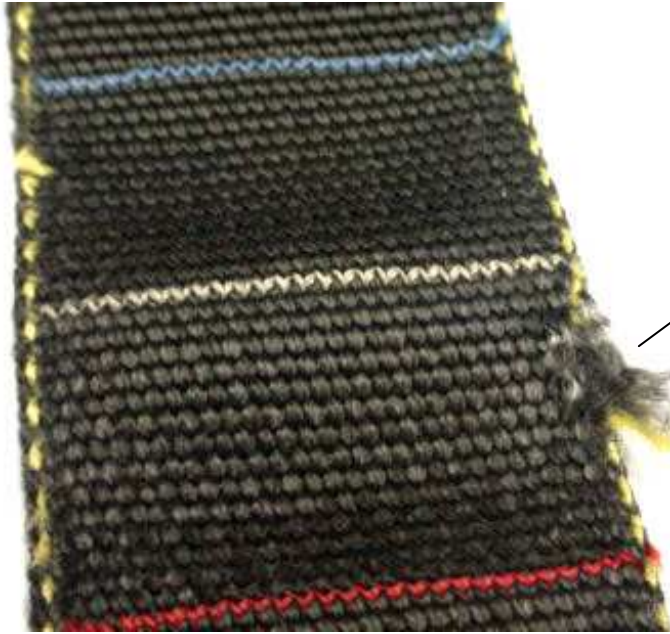
Fig C

Grade 3

- (d) If the finding of the inspection in paragraph (a) receives a grading of “3”, the harness/container system is to be removed from service immediately. The Harness Inspection Record must be submitted to Sun Path Products, Inc. prior to the affected harness sections and /or hardware pieces being replaced and the system re-certified airworthy.

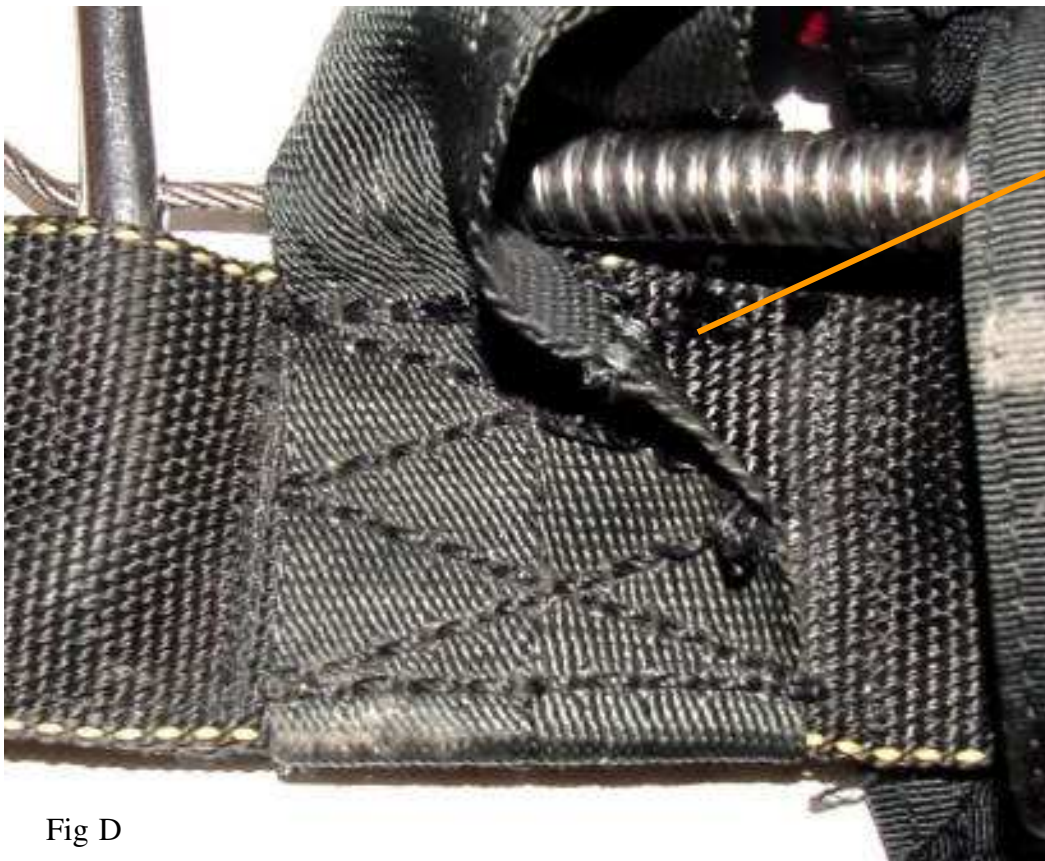
Fig D

Grade 3

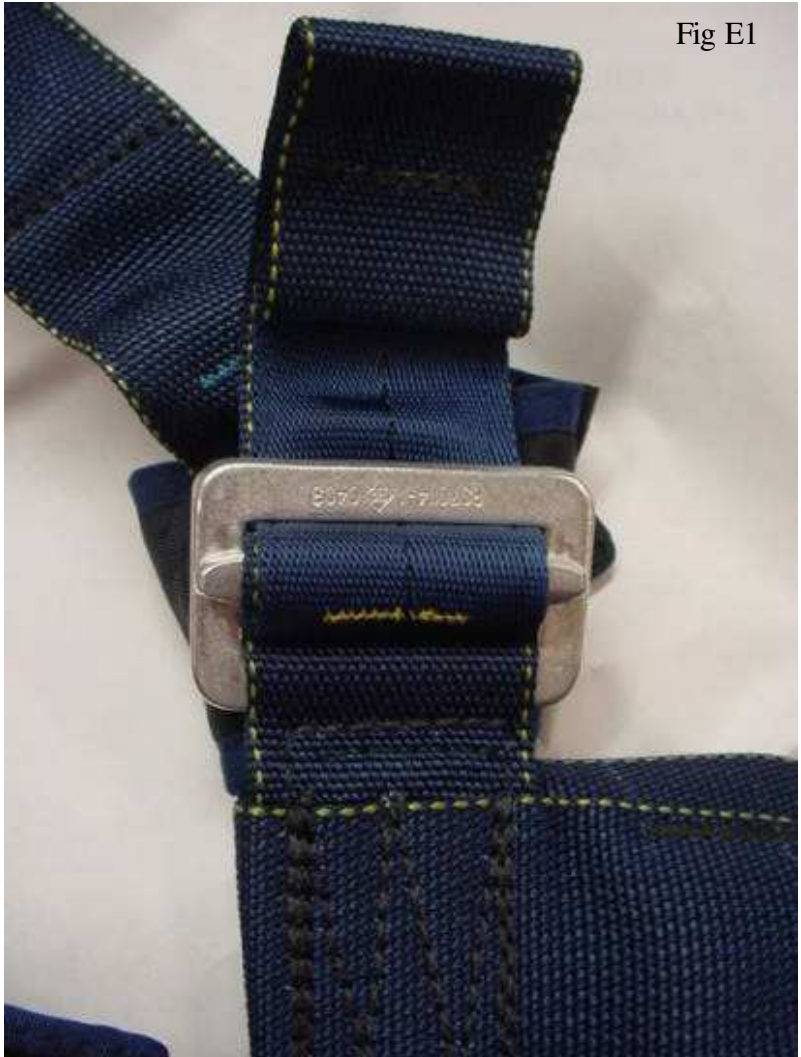
Fig E1

Grade 1- Hardware secured by webbing

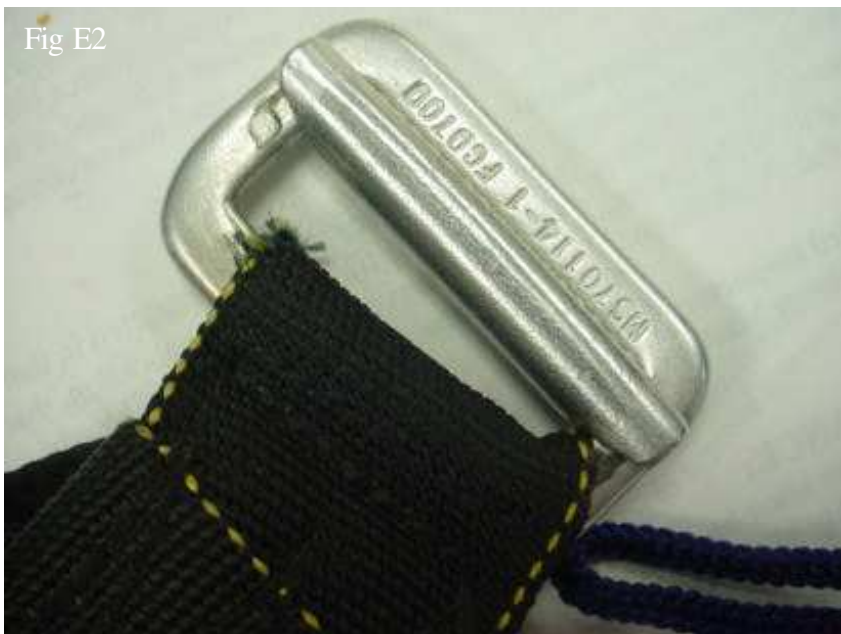
Fig E2

Grade 3 - Hardware able to rotate and/or selvedge damaged
