SICHERHEITSMITTEILUNG **für Sicherheitsautomaten**

Nummer: 13/2011

EMERGENCY PRODUCT SERVICE BULLETIN **(Supersedes Product Service Bulletin PSB-7)**

Bulletin Number : **PSB-8**

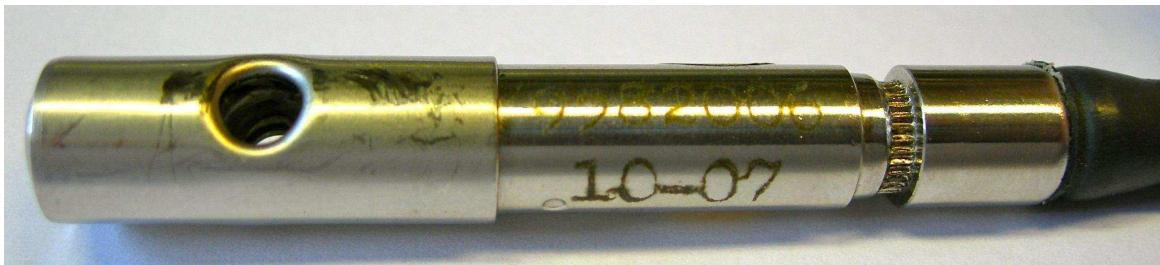
Photo 1

Vigil AAD, All Cutters produced in October 2007

Part Number: 9582006

Date of Manufacture: 10-07 (**mm-yy**)

DOM : October 2007

The cutter was part of a production batch of 299 pieces, produced in October 2007. (See Photo 1.) In the interest of safety, AAD has decided to recall all cutters from the October 2007 cutter batch and to replace all of those cutters free of charge. The removed cutter must be returned to AAD sa/nv or Vigil USA, LLC once the replacement cutter has been received. (Please contact AAD sa/nv or Vigil USA, LLC for return information and instructions.) This will enable us to personally examine and analyze as many cutters as possible from this batch in order to verify that this, in fact, has been an isolated incident.

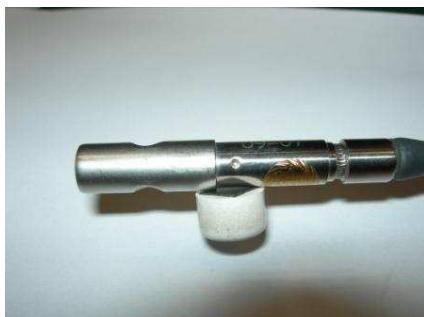
Photo 2 Magnet Test Procedure

In the interest of additional safety, we have devised a field test, which can be performed on any Vigil cutter, using a magnet to confirm the presence or lack of a knife blade. It can be done using any magnet on any cutter. Either a small (see Photo 2A) or a larger (see Photo 2B) magnet may be used. You must ensure that the magnet is placed directly below the closing loop hole portion of the cutter, as shown in Photos 2A and 2B. If there is a knife blade present, the magnet will be attracted to the knife blade. If you require a magnet they are available on request from AAD sa/nv or Vigil USA, LLC.
