**Technische Mitteilung
für Hauptkappen**

Nummer: 02/2012

Betrifft: Austausch der C1 Leinen am NEOS beim NEOS
P / N 317524 - XXX NEOS mit Seriennummern bis 24112612.

SUBJECT: ICARUS Canopies - NEOS hard openings

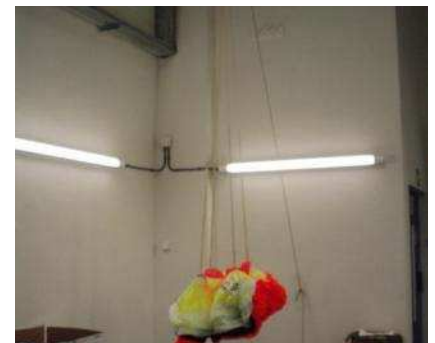
Fig. 2. Hang the canopy with the suspension lines at the same height. If the parachute is assembled on risers, make sure that they are the same length.

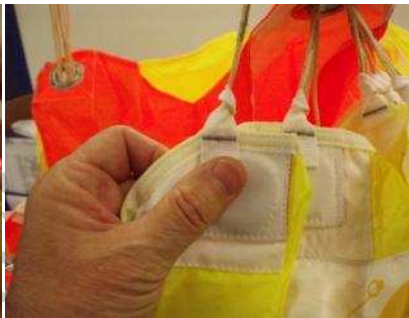
Fig. 10. Check the knot orientation

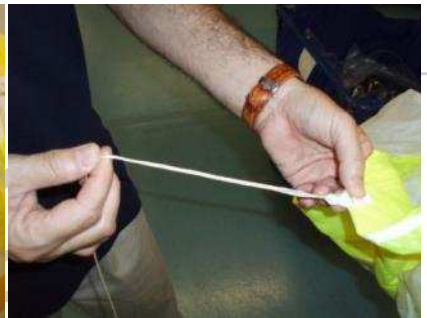
Fig. 11. Make sure there is no twist along the C1 line.

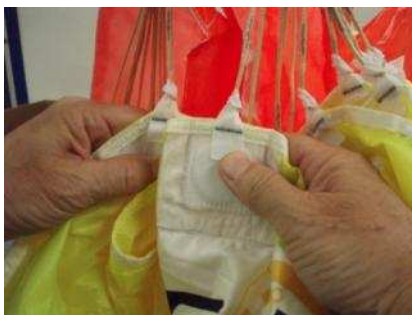
Fig. 15. Take the C1 and B1 attachments and check that they are at the same height.

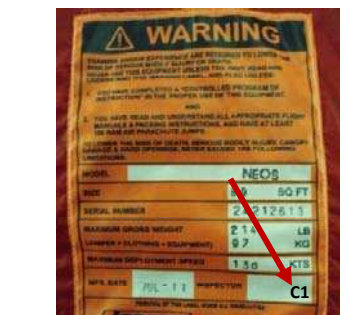
Fig. 17. When the modification is completed, mark "C1" with permanent marker in the inspector box on the warning label.
