SICHERHEITSMITTEILUNG für Tandem

Nummer: 2021-03 SM Strong Tandem Droguebridle

SB #35 Tandem Drogue Bridle 3-Ring Attachment Inspection

SUBJECT: Tandem Drogue Bridle 3-Ring Attachment Inspection

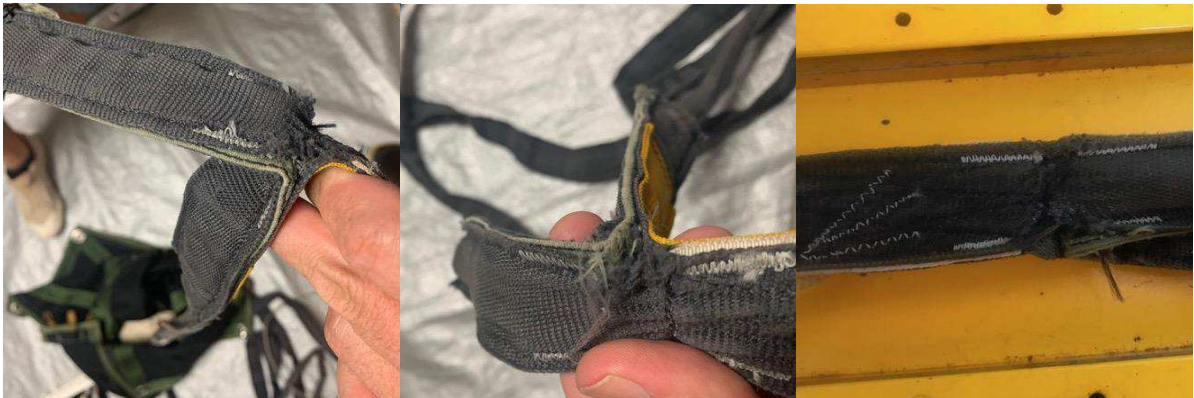
BACKGROUND: Affected Drogues included an engineering change to the stitching junction at the 3-Ring end of the Drogue Bridle using one continuous piece of webbing. While the new configuration performed well during initial testing, End-Users in the field reported accelerated and excessive wear in this location.

SERVICE BULLETIN: All affected Drogues must be grounded until the 3-Ring attachment end of the Drogue Bridle is carefully inspected for accelerated excessive wear. The photos below show a Drogue that was removed from service after approximately 200 jumps and shows excessive wear. While these are not objective parameters, they may be used to guide the Inspector's subjective decision to continue use with subsequent inspection after each jump or remove the Drogue from service. If there is any doubt, remove the Drogue from service.

Drogues removed from service must be returned to Strong Enterprises for rework.
