SERVICE BULLETIN VSESB001

SERVICE BULLETIN VSESB001, REV 0

SUBJECT: MAIN RISER, LOCKING LOOP WEAR

STATUS: MANDATORY INSPECTION

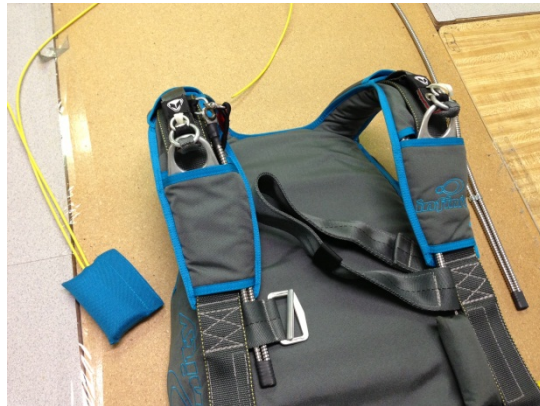
1. Remove the cutaway handle/cables

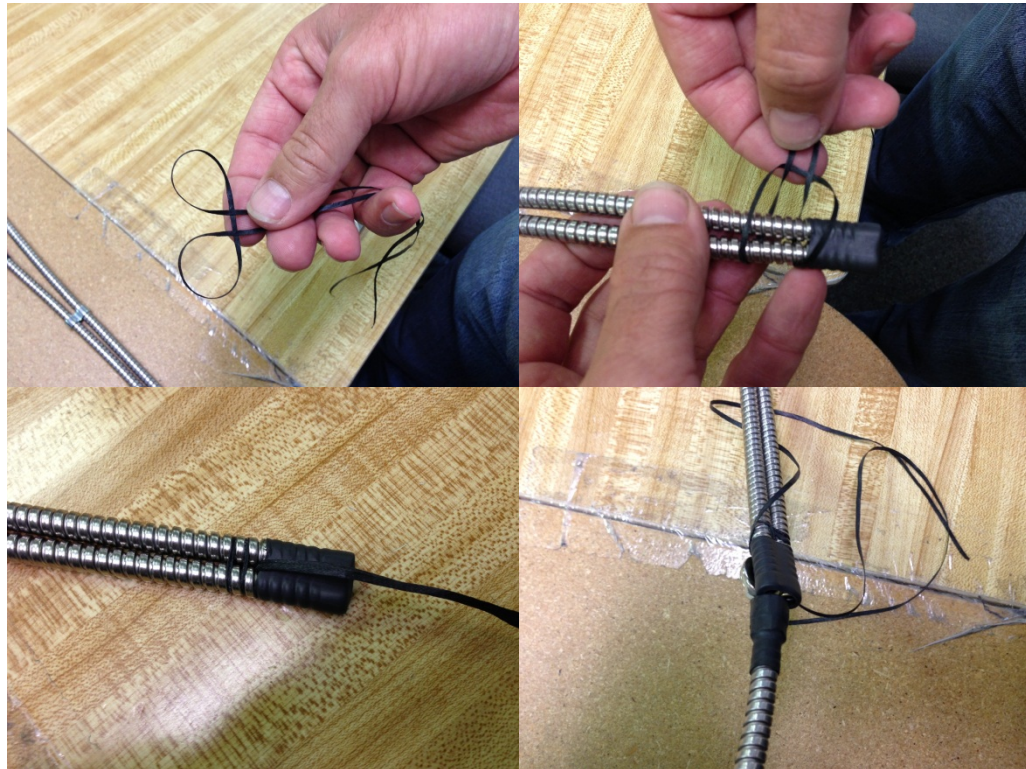
2. In the case of chest articulation, the housings will need to be removed from the double housing clamp which is attached to the handle pocket.
 - a. To remove, twist the housings approximately 60 degrees in both directions. Take care not to bend the housing permanently. This will loosen the clamp to allow the housings to be removed from the clamp connected to the handle pocket.
 - b. Be sure to tighten this clamp once the new housings are installed.
3. Attach the tack cord to both sets of housings
 - a. Tie tack cord on new housings using the double loops shown (end with both housings shrink wrapped)
 - b. Tie tack cord end of old housing (end with amp connector/grommet)
 - c. Ensure the tack cord is secure so it doesn't come undone inside the yoke

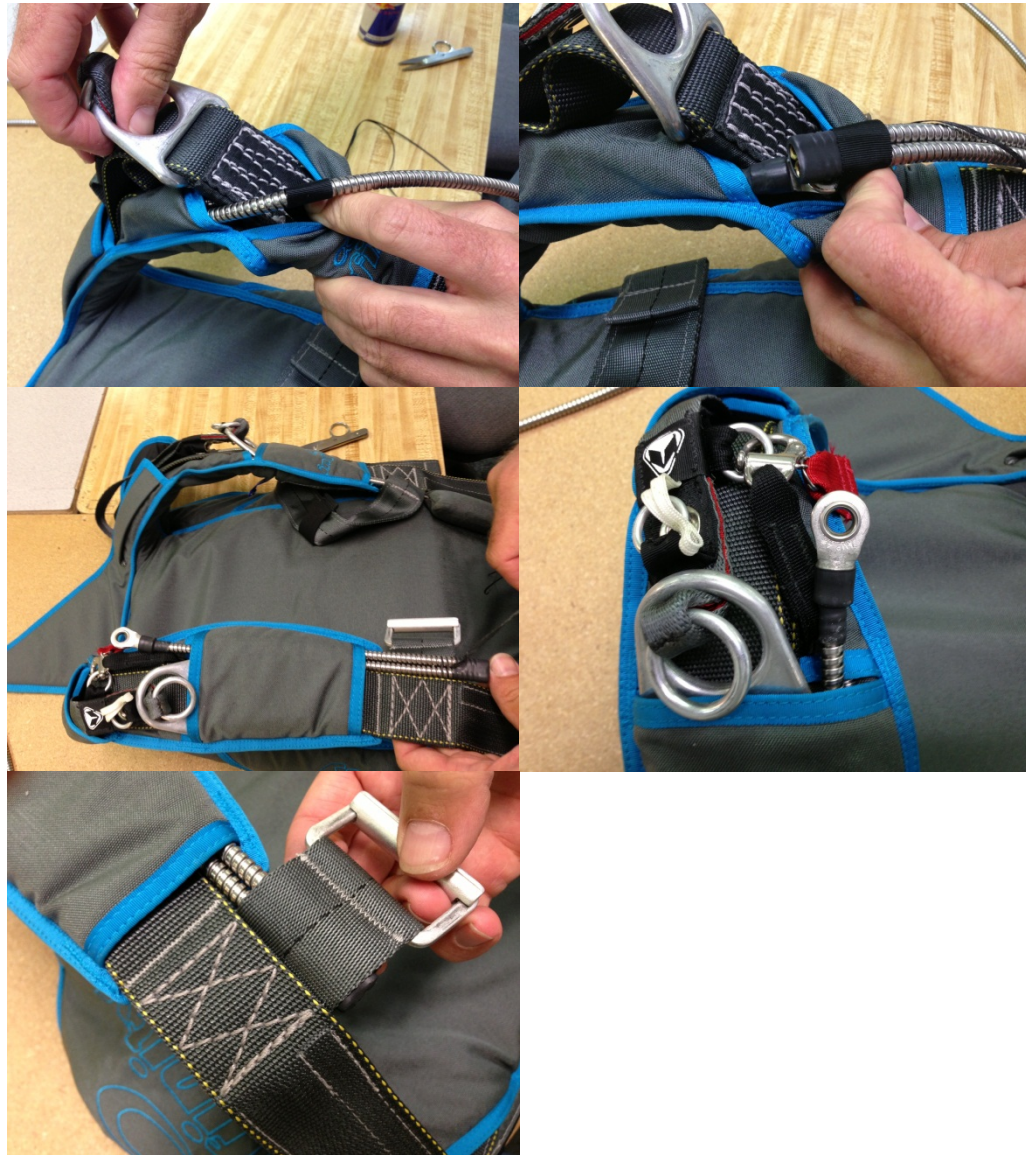
4. Pull the old housings out as you feed the new housings in.
 - a. Partially expose the MLW and $\frac{3}{4}$ " tape loop; both located within the left mudflap
 - b. Pull housing through from below the right side mudflap
 - c. Take care as you feed the tied ends through the binding tape loop
 - d. Take care as you feed the tied ends into the yoke
 - e. Once new housings are completely pulled through, position the new housings so short housing grommet is flat and facing back of rig
 - f. Remove tack cord
 - g. Feed housings through gap in chest strap

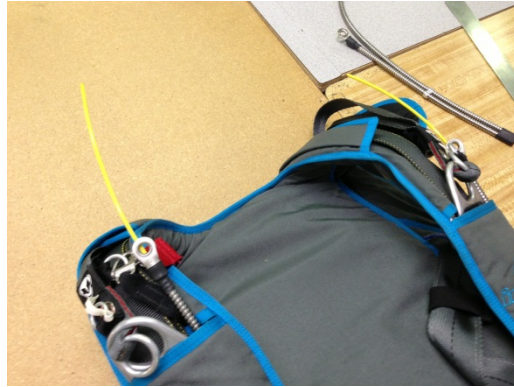
5. Install cutaway handle

- a. Check cable lengths. The cable protruding from the RSL side housing must be 1" longer than the non RSL side.
- b. Cable should be 6" on non-RSL side; 7" RSL side when measuring from the end of the housing. If cables protrude less than 4/5" respectively, the handle should be replaced.

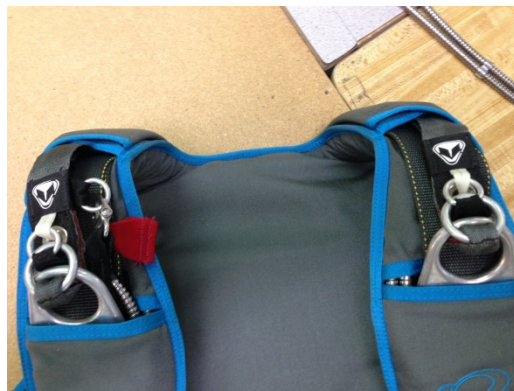
6. Re-assemble the cables and main risers.
