SICHERHEITSMITTEILUNG
für Sicherheitsautomaten

Nummer: 11/2011

EMERGENCY PRODUCT SERVICE BULLETIN
(Supersedes Product Service Bulletin PSB-6)

Bulletin Number : **PSB-7**

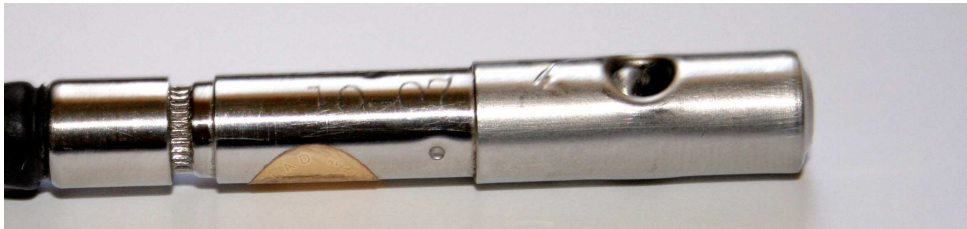
Photo 1

Vigil AAD, All Cutters produced in October 2007
Part Number: 9582006
Date of Manufacture: 10-07 (**mm-yy**)
(See Photo 1.)

Vigil R&D has confirmed that the electronics worked correctly and fired the cutter, but because of the absence of the knife blade, the closing loop could not be cut. **This cutter was part of a production batch of 299 pieces, produced in October 2007. (See Photo 1.)**

were issued from stock or as replacements via our dealers. Therefore, verification of the Date of Manufacture ("DOM") of the cutter must be performed at the time of the next reserve repack. **Every cutter found with a DOM of 10-07 (see Photo 1) must be replaced before the next jump, and the cutter which was removed must be returned to Vigil.** (Please contact AAD sa/nv or Vigil USA, LLC for return information and instructions.)

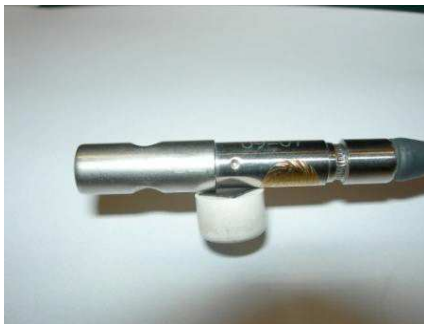
2A

In the interest of additional safety, we have devised a field test, which can be performed on any Vigil cutter, using a magnet to confirm the presence or lack of a knife blade. It can be done using any magnet on any cutter. Either a small (see Photo 2A) or a larger (see Photo 2B) magnet may be used. If there is a knife blade present, the magnet will be attracted to the knife blade.

For additional safety, we highly recommend that the magnet test be performed on each cutter manufactured prior to June 2008.
