SICHERHEITSMITTEILUNG für Gurtzeuge

Nummer: 01/2014

SERVICE BULLETIN VSESB001

SUBJECT: MAIN RISER, LOCKING LOOP WEAR

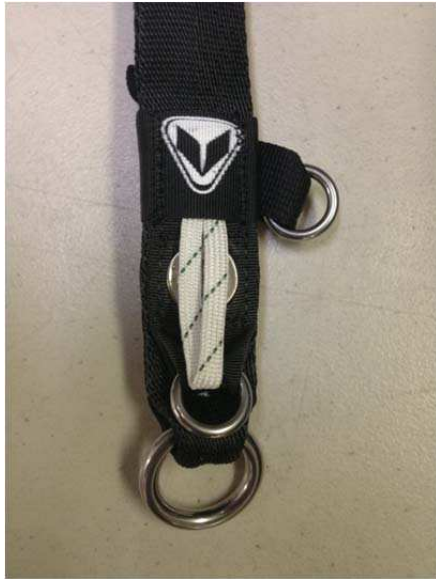
Figure 3: New Locking Loop

The following picture shows a new riser locking loop.

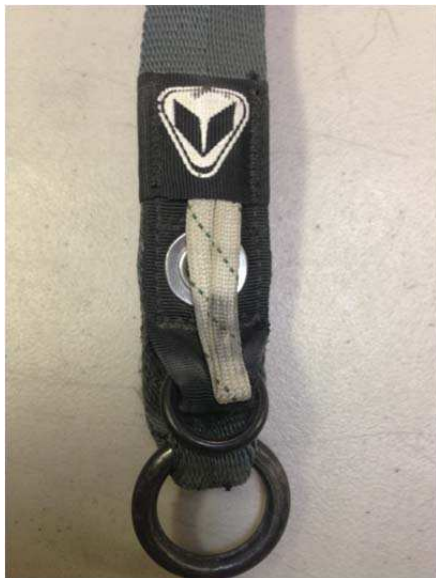
Figure 3: Normal Wear, Front

The following pictures show locking loops with normal wear.

If the loop shows normal wear, the rig can continue to be jumped and no immediate repair is needed.

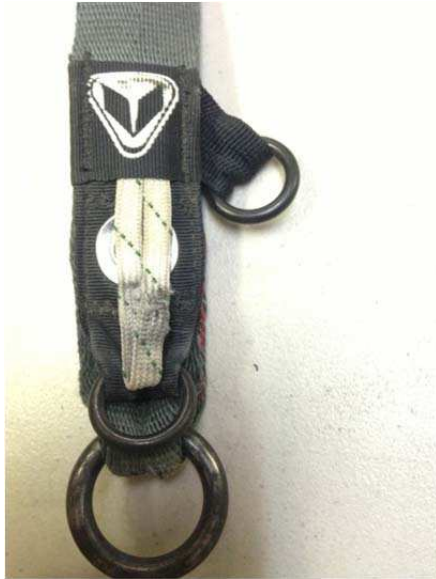
Figure 5: Damaged, Frayed

Several main risers have been found in the field with frayed/partially cut locking loops (the white type 2A loop). The amount and location of damage on the loops varies, leading VSE to conclude there may be several contributing factors.

A loop failure can result in an out of sequence main release and reserve deployment which can cause an entanglement. Due to this danger, VSE feels all main risers should be inspected according to the following Service Bulletin.

The following pictures show locking loops with damage; heavily frayed and partially cut.

If the loop shows signs of damage, the rig should not be jumped and VSE should be contacted for further instructions. VSE may also ask for additional information to help determine the root cause and most effective repair. At minimum, VSE will need 2-4 photos, one of each riser loop and one of each housing grommet. Please have these available to send to VSE when you call in. In most cases, once the root cause is determined, VSE will provide a parts kit which can be installed by an FAA certified senior or master parachute rigger or foreign equivalent using the Housing Replacement Procedure provided at the end of this service bulletin. In certain cases, VSE will require the rig be returned to VSE for further inspection and repair.

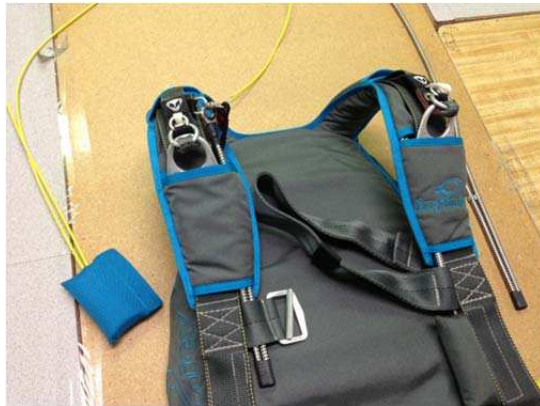
1. Remove the cutaway handle/cables

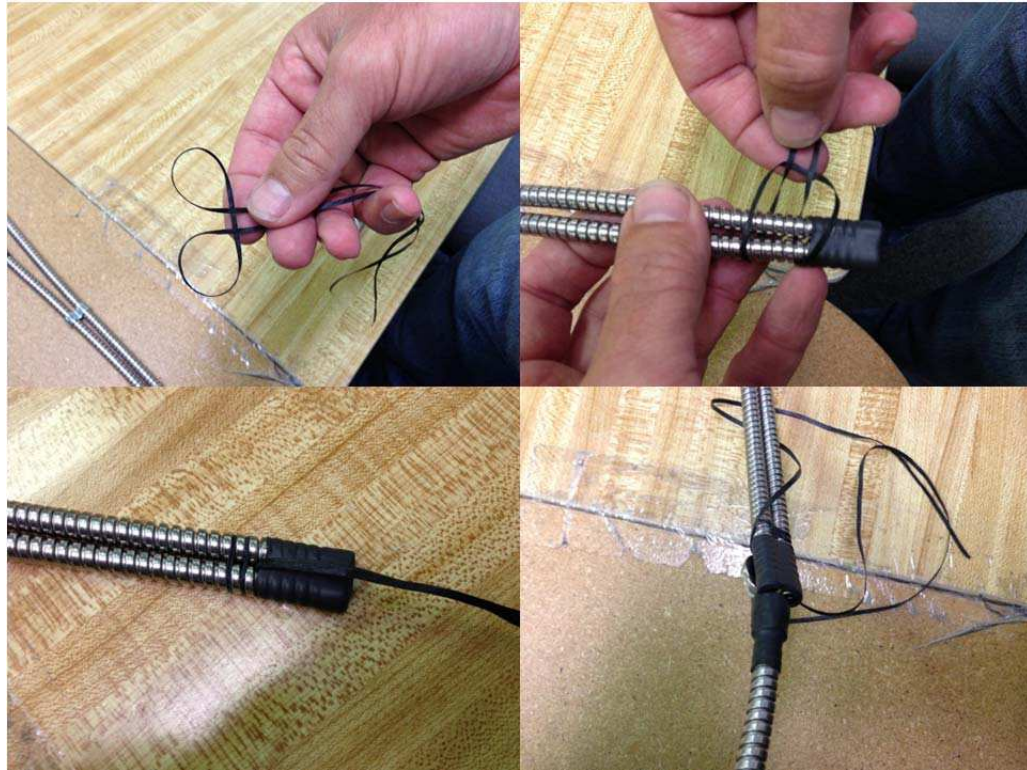
2. In the case of chest articulation, the housings will need to be removed from the double housing clamp which is attached to the handle pocket.
 - a. To remove, twist the housings approximately 60 degrees in both directions. Take care not to bend the housing permanently. This will loosen the clamp to allow the housings to be removed from the clamp connected to the handle pocket.
 - b. Be sure to tighten this clamp once the new housings are installed.
3. Attach the tack cord to both sets of housings
 - a. Tie tack cord on new housings using the double loops shown (end with both housings shrink wrapped)
 - b. Tie tack cord end of old housing (end with amp connector/grommet)
 - c. Ensure the tack cord is secure so it doesn't come undone inside the yoke

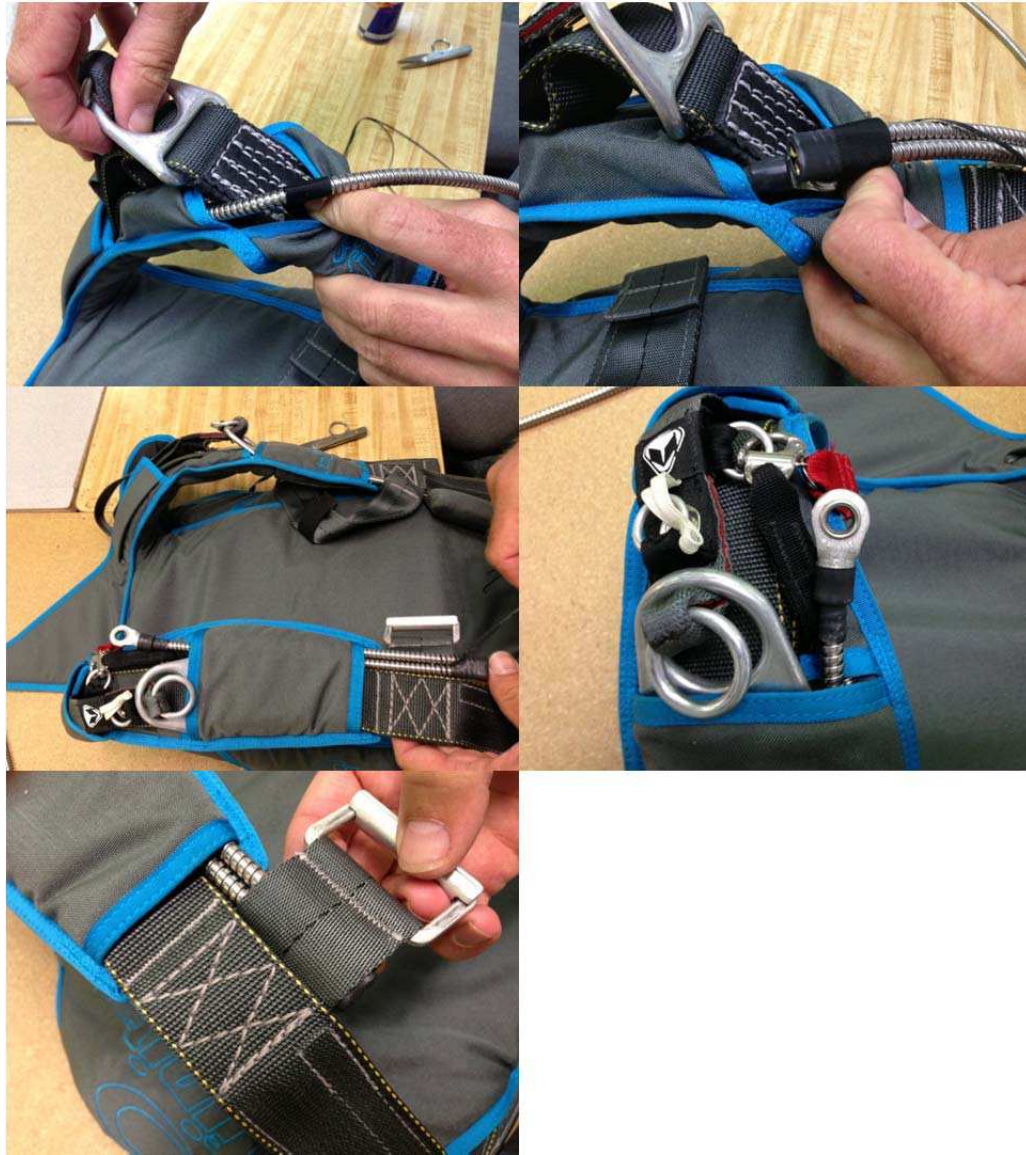
4. Pull the old housings out as you feed the new housings in.
 - a. Partially expose the MLW and $\frac{3}{4}$ " tape loop; both located within the left mudflap
 - b. Pull housing through from below the right side mudflap
 - c. Take care as you feed the tied ends through the binding tape loop
 - d. Take care as you feed the tied ends into the yoke
 - e. Once new housings are completely pulled through, position the new housings so short housing grommet is flat and facing back of rig
 - f. Remove tack cord
 - g. Feed housings through gap in chest strap

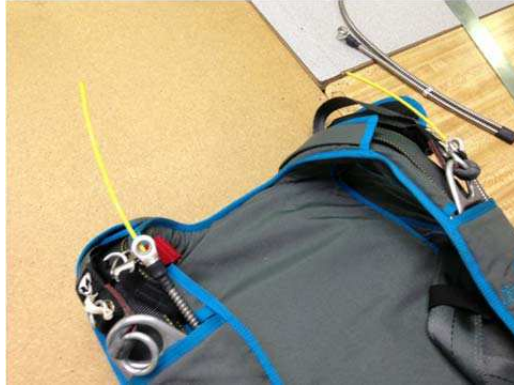
5. Install cutaway handle
 - a. Check cable lengths. The cable protruding from the RSL side housing must be 1" longer than the non RSL side.
 - b. Cable should be 6" on non-RSL side; 7" RSL side when measuring from the end of the housing. If cables protrude less than 4/5" respectively, the handle should be replaced.

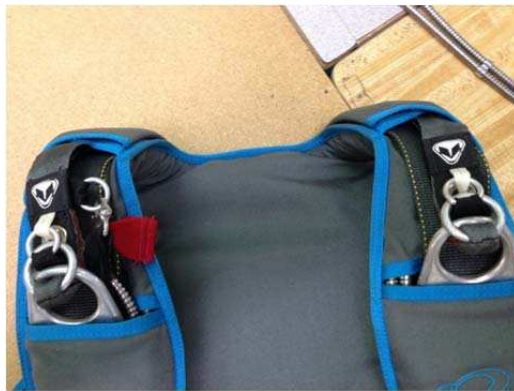
6. Re-assemble the cables and main risers.
