## SICHERHEITSMITTEILUNG für Gurtzeuge

Nummer: 01/2016 3. Ausgabe (Update) Erweiterung der SM vom 18. Jan. 2016

## PRODUCT SERVICE BULLETIN 2016-01 (PSB # 2016-01) Update 2

**SUBJECT:** Stainless Steel Base Ring Hardware on Vortex Harness Containers with DSF stamp or Daesung logo (as pictured)

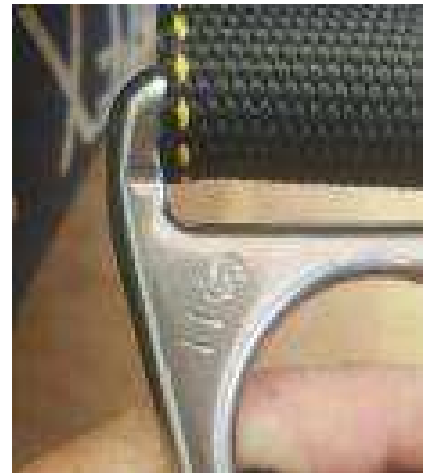
Betroffene Muster: **alle Vortex Gurtzeuge mit Hardware aus Edelstahl bei dem das Logo „DSF“ und zusätzlich die Hardware, bei denen wie im Bild dargestellt, das Logos auf der Hardware eingepreßt ist. Eine kleine Anzahl von Gurtzeugen wurde im Jahr 2011 mit dieser Hardware produziert.**

Grund: Bruch eines Ringes

Status: **Die betroffenen Gurtzeuge mit dieser Hardware sind für immer gegroundet!**

Maßnahmen: Die betroffenen Gurtzeuge müssen zum Hersteller geschickt werden. Im Tausch baut dieser ein neues Gurtzeug auf Grundlage der originalen Bestellung mit neuer Hardware. Dieses wird nach neuestem Standart mit Skyhook-Vorbereitung und Magnetic Cover für die Riser gefertigt. Größen- oder Optionsänderungen sind gegen Aufpreis möglich.

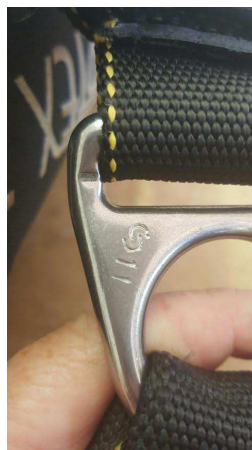
A small number of harness containers were produced by Parachute Systems in 2011 with stainless steel base ring as pictured below:

These DO form part of the recall and are in addition to the ones referenced in the original Bulletin (PSB#2016-01) stamped "DSF".

The original Bulletins are hereby corrected and should include the harness containers with the rings stamped as this picture indicates. All references in all Bulletins and Notices include products with either one of these stamps on the stainless steel base rings.

**Harness containers with stainless steel base rings with either or both of these stamps are immediately grounded and affected by the recall.**

These should immediately be registered and returned for replacement.

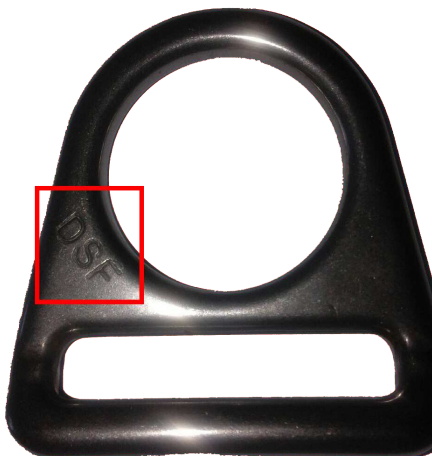
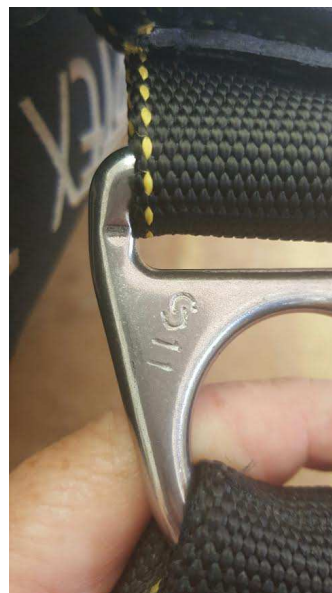
All DSF/and Daesung logo printed Stainless Steel Hardware (Part Number: H38005) ,this includes the stainless steel mini base ring and hip and chest rings identifiable by DSF stamp and logo stamp as in picture below.

On January 2nd, 2016, a photograph of a stainless steel ring with DSF imprinted on it was sent to us by our dealer in Holland. This ring was observed by a jumpmaster/loader prior to boarding. We think the ring cracked and was pulled apart by about ten millimeters on one side, on the previous opening. The harness/container only had four jumps on it, according to the dealer. Without much information and due to the holiday weekend, we were unable to assess exactly what had occurred and we therefore ground all the Vortex containers with this stainless steel hardware pending a full investigation in the interests of safety.

**STATUS:** **All Harness Containers with Stainless Steel base ring hardware stamped DSF AND with Daesung logo are Permanently Grounded (Product Recall)**

2. It has been decided, therefore, that every Vortex Harness Container with the stainless steel hardware as referenced in the Bulletin and stamped "DSF" BE GROUNDED PERMANENTLY.

4. It has been further agreed to by both companies, that EVERY Vortex harness container that has the stainless steel hardware as referenced in the initial Bulletin, will be replaced with a brand new identical Harness Container as the original order.
