# Deutscher Fallschirmsportverband (DFV) e.V.

Nummer: **2026-06 Info TM Aerodyne Icon Reserve Abdeckklappe**

## Technical Bulletin TB220526

### Aerodyne ICON H/C reserve top flap modification

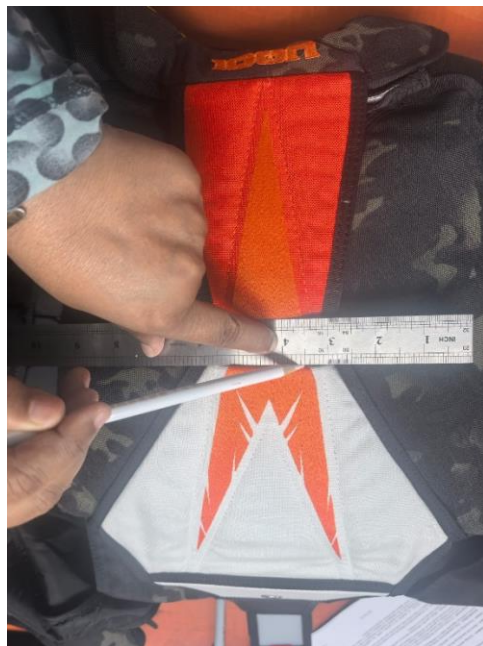
Figure 1.2

Mark the Position of the Reserve Pin Flap as shown in figure 1.2.

Note, this distance may vary when the Harness and Container is worn

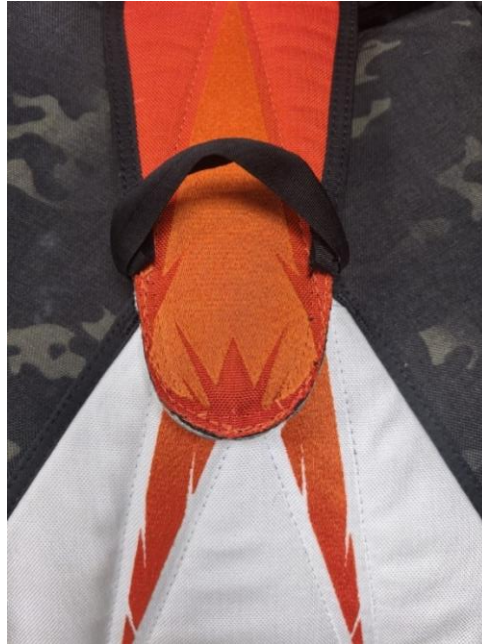
Figure 2.2

Unpick the edge binding as per picture 2.2. Unpick the basting stitch as per picture 2.3

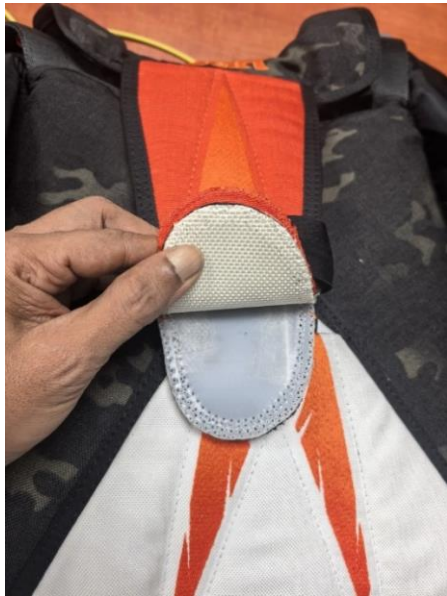
Identify the plastic panel as shown in Figure 2.4

Mark the plastic as per the distance measured in Figure 1.3

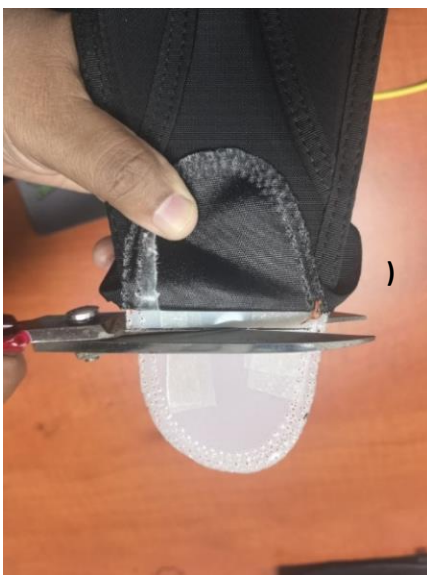
Cut the Plastic as per Figure 2.6 NOTE : only cut the Plastic, Do NOT cut the Ballistics and other Materials

After cutting the plastic as in figures 2.6 and 2.7, cut a very small diagonal at the remaining edge of the plastic to remove the potentially sharp point.

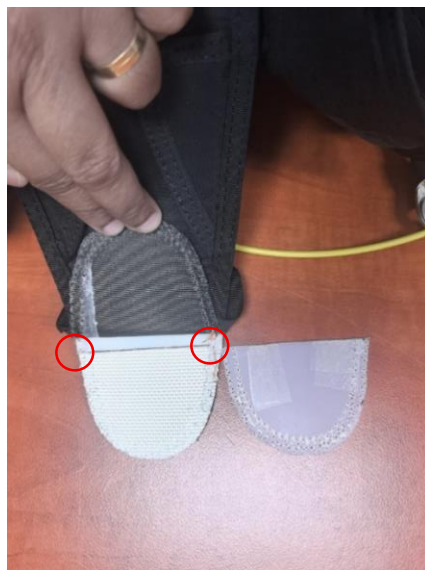
Figure 2.7 Plastic cut

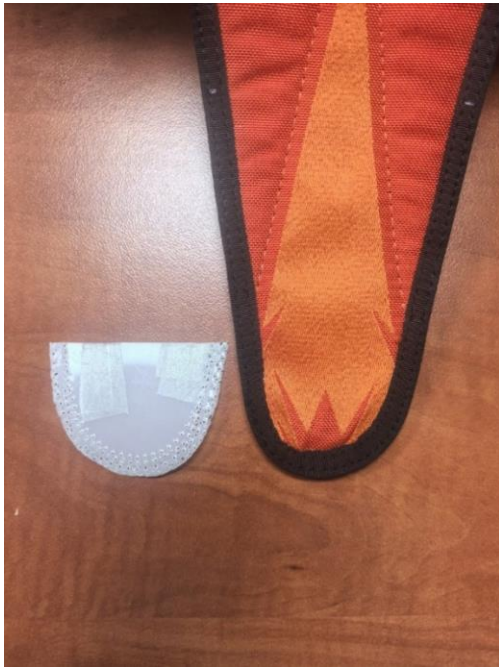
Figure 2.8

Rebind as shown in Figure 2.8. Note the Plastic Piece has been Removed

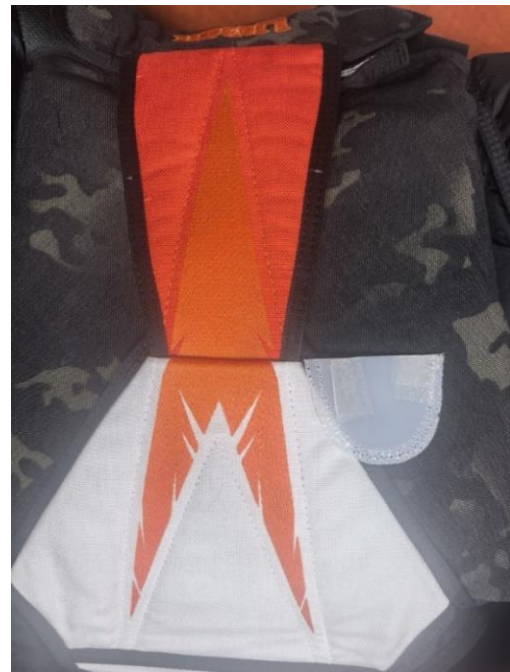
Figure 1.9

Modification is Complete
