INFORMATION BULLETIN: VIGIL CUTTERS

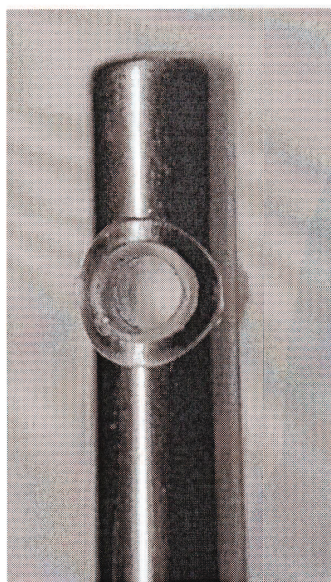
TYPE 1

All cutters with plastic protection heads (see picture Type 1).

Cutters produced up to July 2006 or Vigils with serial numbers from #1100 to #6591.

Statement of some degradation on plastic protection heads of our cutter Type 1.

All cutters **mounted at the bottom** of the rig are NOT concerned, as long as the plastic protection heads are not damaged.

This must be verified at EACH repack.

IF the plastic is damaged, the cutter **MUST be replaced**.

If your cutter with plastic protection head is mounted above the extractor, there is a risk that it is pressed between two rings. This could create a degradation risk, due to the pressure caused by those inox rings on the plastic heads and cutters **MUST be replaced**.

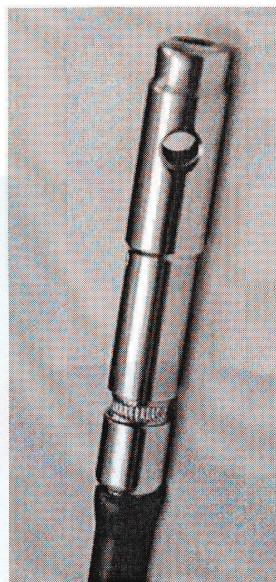
TYPE 2

All cutters with full stainless steel body (see picture Type 2).

Cutters produced from August 2006 to March 2007, or Vigils with serial numbers from #6860 to #7945.

Due to some inside burs on cutters that were supplied by a second sub-supplier, we stated that some of those cutters could damage the loop.

All these cutters **MUST be replaced** and can be exchanged free of charge via your dealer, via A.A.D. sa (Brussels) or VIGIL USA.

To be done at the next repack.

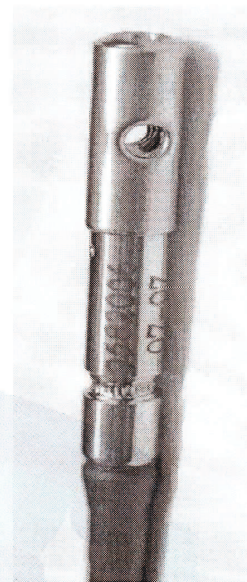
TYPE 3

All cutters with a stainless steel sleeve and inside vinyl tubing (see picture Type 3).

Cutters produced since July 2007.

Vigil serial numbers from #8000.

ALL these cutters are good and therefore NOT concerned by this Information Bulletin.

Some of those cutters could have an inside bulb on the soft vinyl tubing, but this can not cause any damage to the loop.
